## **A Hydrogeological Investigation Report on Land Subsidence in Joshimath Town, Chamoli District, Uttarakhand**

**By**  
**Central Ground Water Board,**  
**Department of Water Resources, River Development and**  
**Ganga Rejuvenation, Ministry of Jal Shakti**  
**Govt of India, Dehradun**

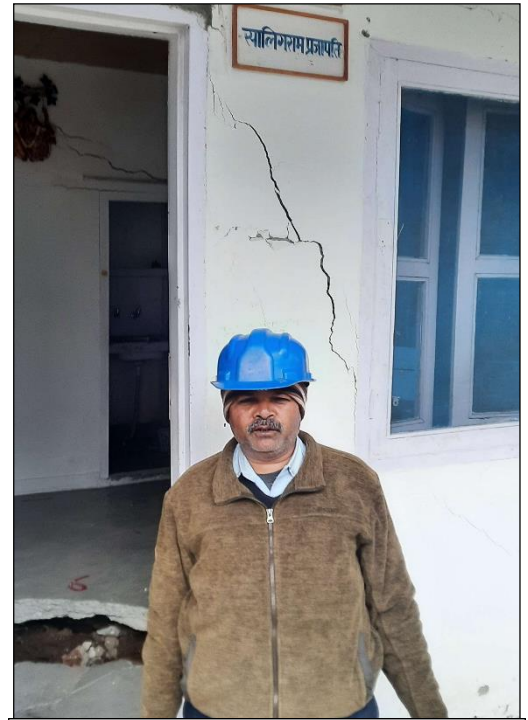
**Photo -1 House of Sh Salig Ram Prajapati, JP Colony, Joshimath**

In conversation with the local people in Manoharbagh area, it comes to know that the cracks in the agricultural land of Sh Suraj Kaparuwan was noticed on last week of November 2022. It was very less in its extent. Cracks in the residential building have been observed at about 9 PM on 2/ 3<sup>rd</sup> Jan 2023 as told by Sh Salig Ram Prajapati, employ of J P Power Project (Photo - 1). In the morning of 03 January 2023, the moderate to intensive land subsidence was observed just below Auli, Sunil Village upto Marvadi Village.(Photo-2) The Cracks developed in North – South direction having average width of 10-15 m. Further, water burst out in JP residential premise in Marwari Village. Initially, discharge was about 650 lpm which is reducing with time upto to the tune of 225 lpm.

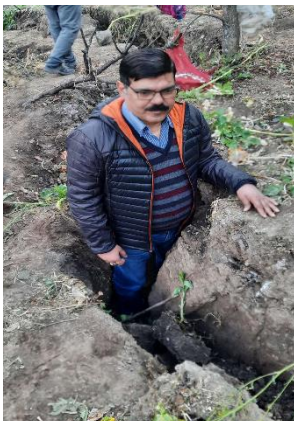
**(C) Vertical Cracks (about 3 ft) at Manohar Bagh**

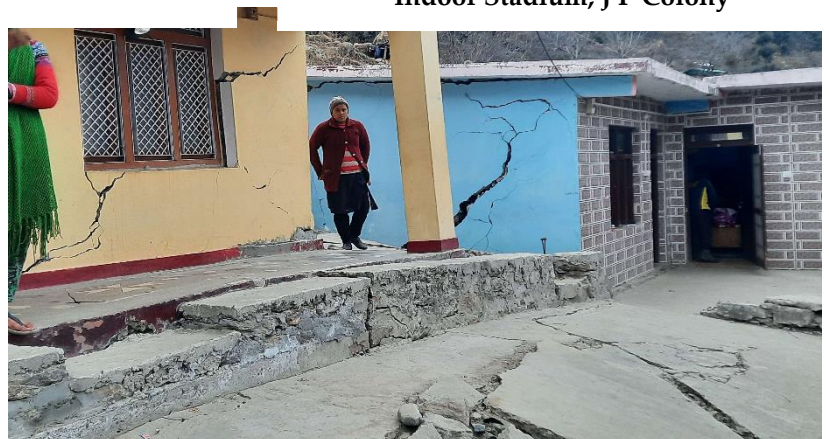
**(D) Cracks Developed in House of Sh Vinod Saklani, Sunil Village**

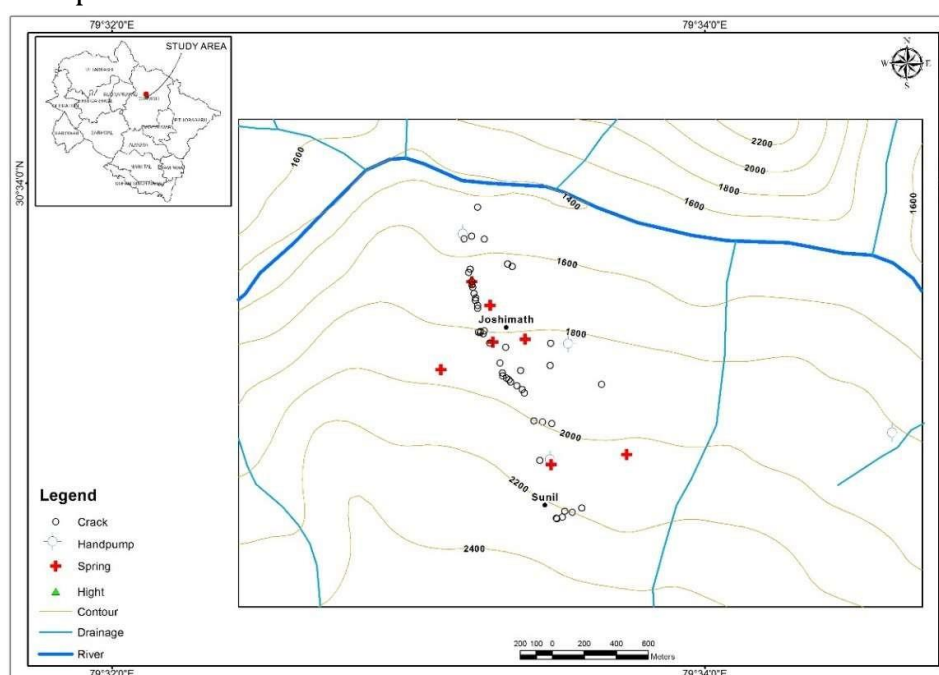
**Figure- 3 A Location of Cracks, Springs and Hand pumps in the Joshimath Town, Chamoli District, Uttarakhand.**

A total of 46 cracks/subsidence zones are observed which are oriented in North-West to South-East direction (Figure- 3 A) (Annexure- I). The slope direction of the study area is South to North. (Figure- 3 B) The crown of the subsidence marks at house of Sh Vinod Saklani, Village Upper Sunil and extend upto JP township at Marwari village. The intensity of the cracks is increasing from south to north and it maximum observed in Manohar Bagh area where one of the hotels building lean over adjoining hotel building. The depth of the cracks observed in the agriculture land is upto 03 ft deep and 1-2 ft wide.

- Cracks, spring location and handpumps constructed in the area are plotted (Figure 3 A and 3 B). It is observed that they are aligned in the same zone. Occurrence of all three in the same zone may indicate that strata saturated with the ground water may prone to land subsidence. In the area, zone tapped for handpump is 65 -80 m below ground level which indicates that formation saturated with ground water may located at a depth of 65 -80 m bgl. The decline in depth to water level at Singhdhar handpump indicates that water bearing strata is linked with the land subsidence. Land subsidence may be extended in and around Singhdhar Handpump.

- It is suggested that trench along with the retention wall may be constructed at different topographic level so that ground water pressure may be dissipated and cracks in futures will be cease.
- Construction activities in spring zone area should be immediately stopped.
- Emergence point of the springs which are covered with any concrete material should be cleared immediately.
- Work on Helang – JP colony Bypass Road should be started and completed at earliest. As this Bypass road will reduced the load of floating population on the town and ultimately retard the pace of construction activity in the town.

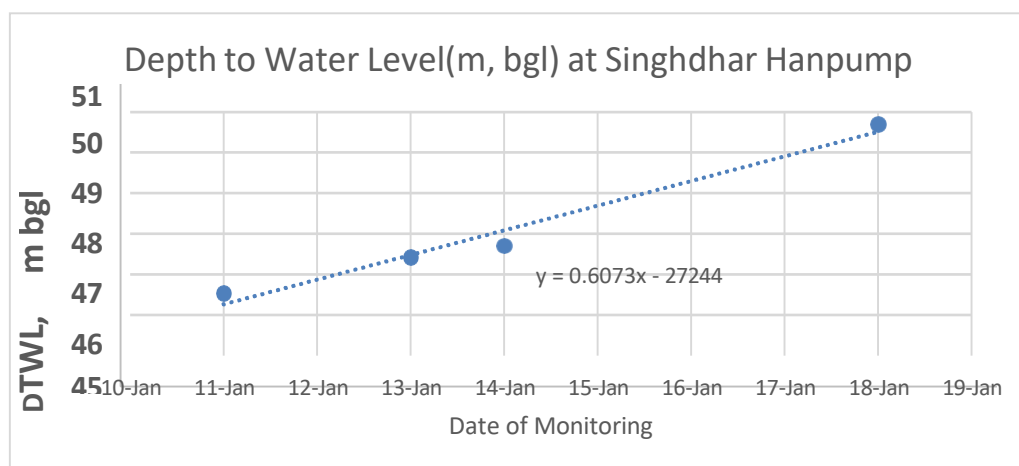
**Figure 4 – Hydrograph of Singhdhar Handpump Joshimath Town, Chamoli District**

Joshimath town is situated on morainic deposit, comprising thick Quaternary loose sediment. Big boulders are embedded in this deposit. The morainic deposit is both porous and permeable and hence suitable for groundwater development. The ground water is mainly developed through handpumps. The topography is highly undulating and geological formations are moderately to steeply dipping. Due to frequent undulations of high magnitude a continuous water table doesn't exist. However, permeable formation overlays an impermeable one, the water table exists, its extension depends upon the distribution of the aquifer forming rocks and topography. A total of 04 number of handpumps are present in the study area (Figure 3 A & 3 B) and as per the data available with Jal Sansthan, Joshimath, the handpump are drilled upto the depth of about 80 m and the zone tapped ranges from 65-80 m bgl. The depth of water level in these handpumps ranges between 18 to 48 m. Daily depth of water level has been monitored and it is observed that water level is declining in Singhdhar area, with various rate. 20- 60 cm per day, (Figure- 4) while in other handpumps the water level is almost content. (Table-2) The decline in Singhdhar handpump indicates that water bearing strata is linked with the land subsidence. Land subsidence may be extended in and around Singhdhar Handpump. The discharge of these handpumps was taken manually which is 17.65-20.27 lpm

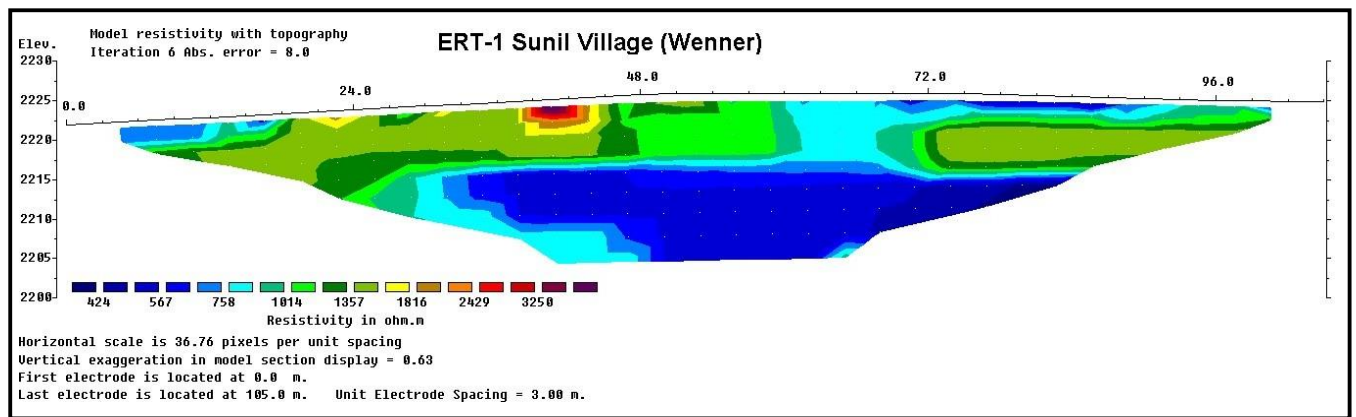
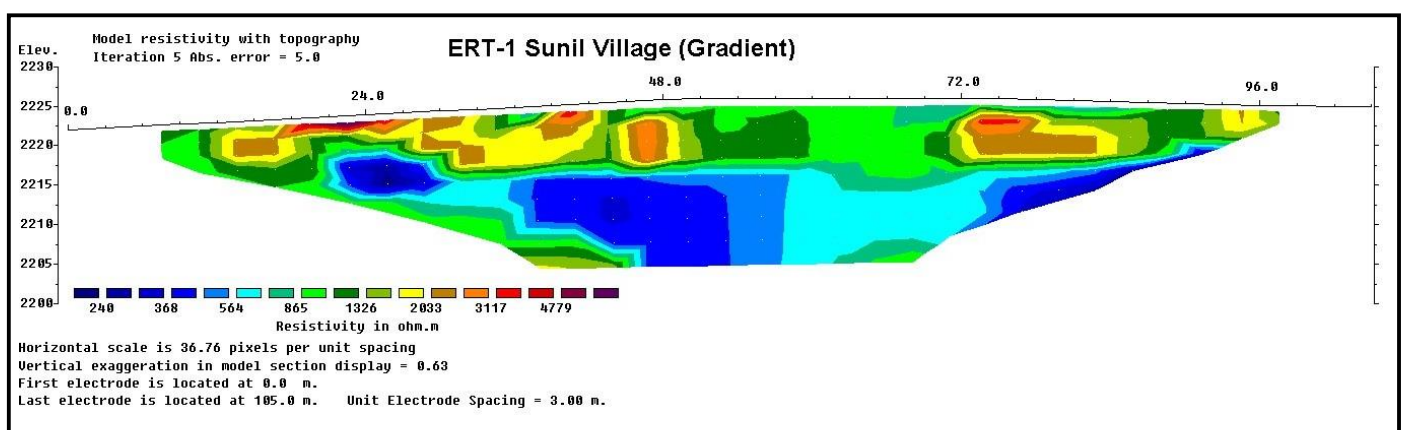
**Figure 7 A: 2-D Electrical Resistivity Tomography Section (Wenner) at Upper Sunil Village, Joshimath (ERT-1), Chamoli District**

**Figure 7 B : 2-D Electrical Resistivity Tomography Section (Gradient) at Upper Sunil Village, Joshimath (ERT-1), Chamoli District**

First 2D electrical resistivity tomography (ERT-1) has been carried out across the cracks developed in agricultural land of Sh Vinod Saklani Joshimath area, District Chamoli, Uttarakhand. Length of ERT profile was 105 m. Resistivity value received during ERT indicates that boulders are embedded into loose sediments. Saturated formation occurs at a depth of 15 m below ground level (Figure 7A & 7 B).

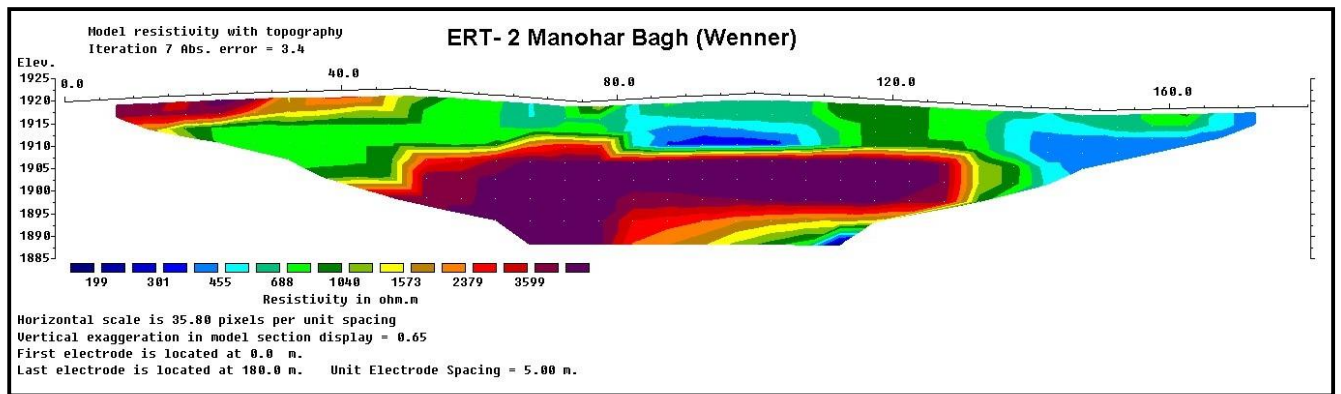
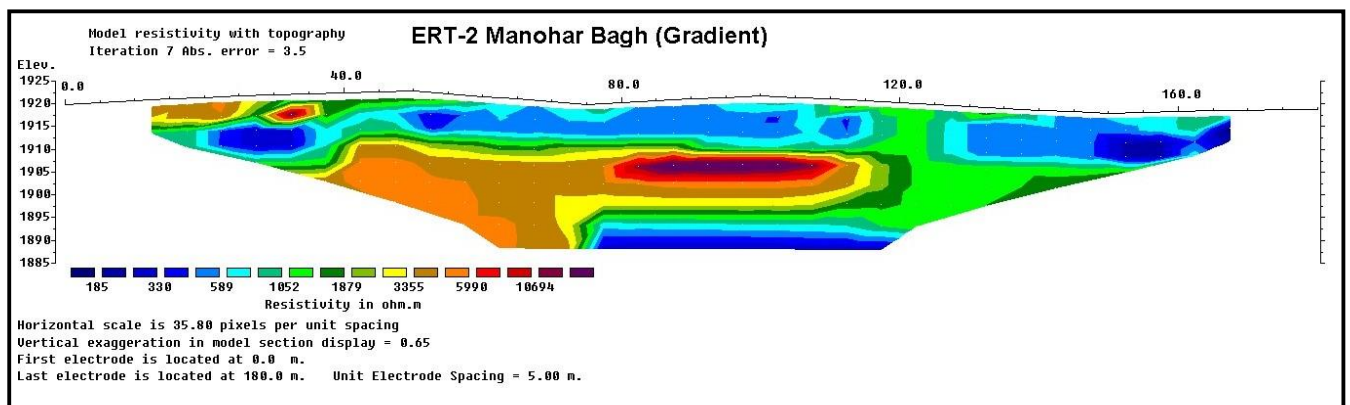
Figure 8A: 2-D Electrical Resistivity Tomography Section (Wenner) at Manohar Bagh, Joshimath (ERT-2), Chamoli District

Figure 8B: 2-D Electrical Resistivity Tomography Section (Gradient) at Manohar Bagh, Joshimath (ERT-2), Chamoli District

Second ERT has been conducted at Manohar Bagh area of Joshimath town where intensity of cracks is maximum. Length of ERT profile was 180 m and maximum depth of investigation is about 35 m bgl. Altitude of the ERT point is 1920 m amsl and it is about 500 m distance towards north from ERT-1. The ERT results shows that the loose formation and boulders are present under saturation with water below the depth of 30 m bgl (Figure 8A & 8 B).

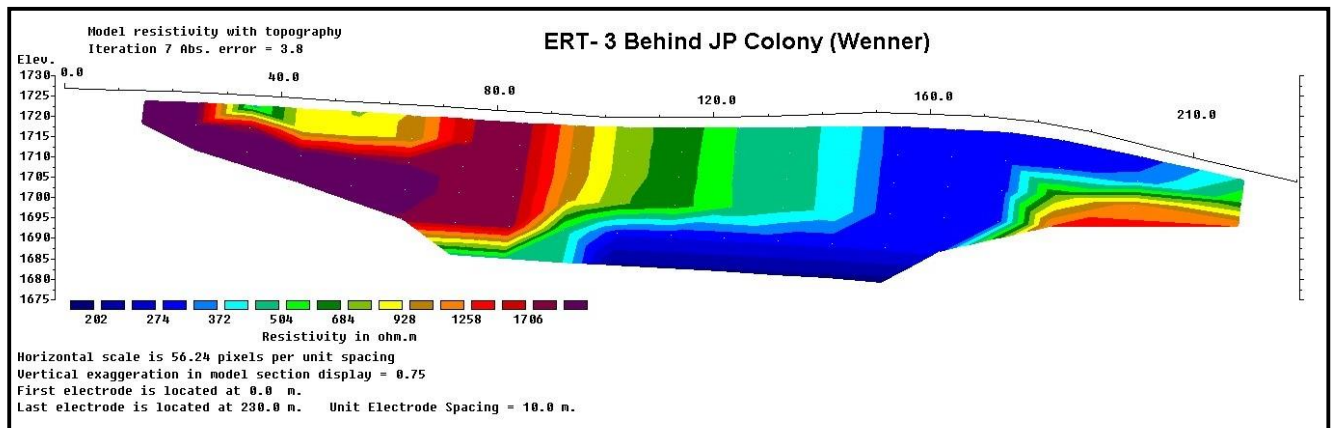
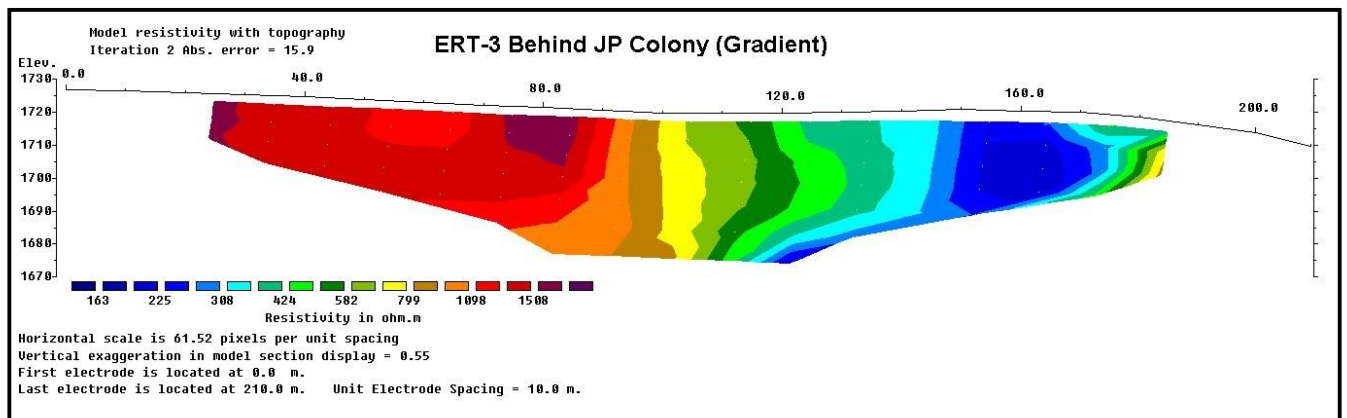
**Figure 9 A : 2-D Electrical Resistivity Tomography Section (Wenner) between Singhdhar and JP Premise, Joshimath (ERT-3), Chamoli District**

**Figure 9 B : 2-D Electrical Resistivity Tomography Section ( Wenner) between Singhdhar and JP Premise, Joshimath (ERT-3), Chamoli District**

Third ERT was conducted 200 m south of the spot where sudden gush of water occurred on 2 / 3<sup>rd</sup> of January 2023. Here, the spread of ERT profile was 230 m and maximum depth of investigation was about 50 m (Fig.9A & 9B). ERT-3 results shows that area lying west of the cracks zone is consolidated in nature. East of the cracks zone have resistivity values in range of 200 – 300 ohm.m at a depth of 10 m to 50 m bgl which indicates the formation encounter in this depth range is saturated with water on the ERT profile between distance 100 and 170 m. It has the 70 m in horizontal extends which may act as path of the subsurface water flow.

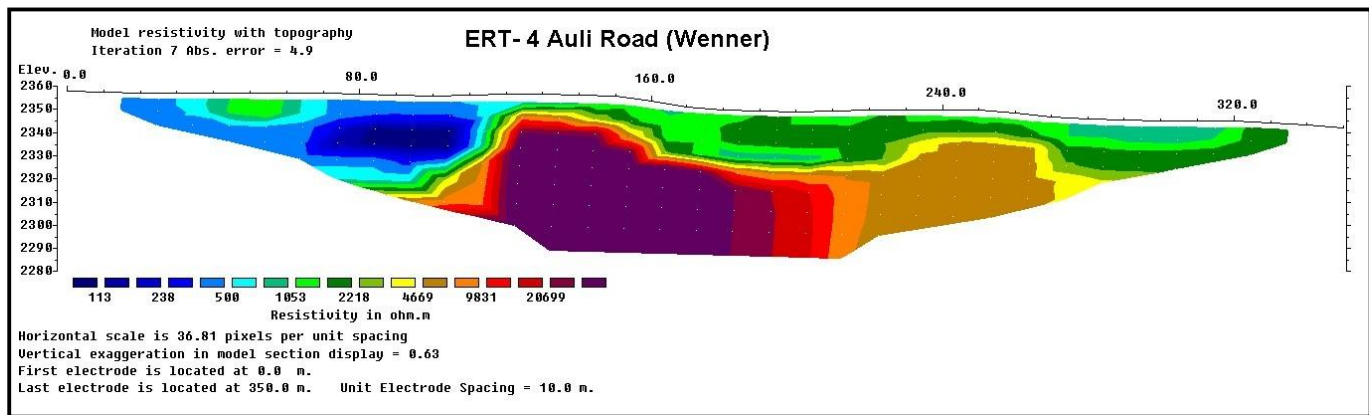
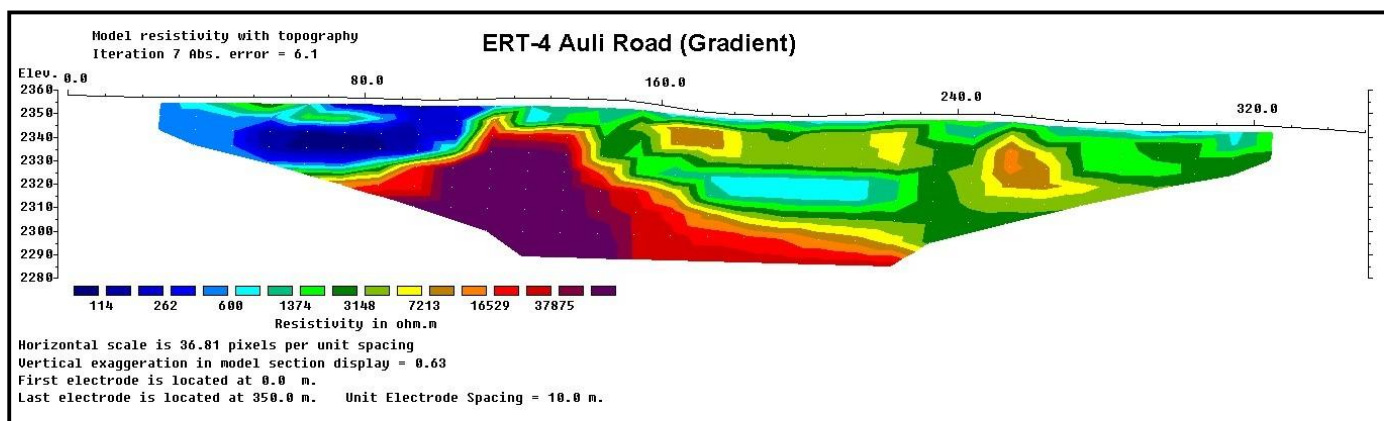
**Figure 10 A: 2-D Electrical Resistivity Tomography Section (Wenner) at Auli Road above the crown of subsidence, Joshimath (ERT-4)**

**Figure 10 B : 2-D Electrical Resistivity Tomography Section ( Gradient) at Auli Road above the crown of subsidence, Joshimath (ERT-4), Chamoli District**

ERT-4 carried out along the Auli road in NW-SE direction about 200 m towards SW of the Sunil Village (Fig. 10 A & 10 B). A patch of low resistivity (100-300 ohm.m) was observed on the ERT-4 profile line between the distance of 50 and 100 m indicates the presence of saturated loose formation with boulders up to depth of about 25 m bgl.

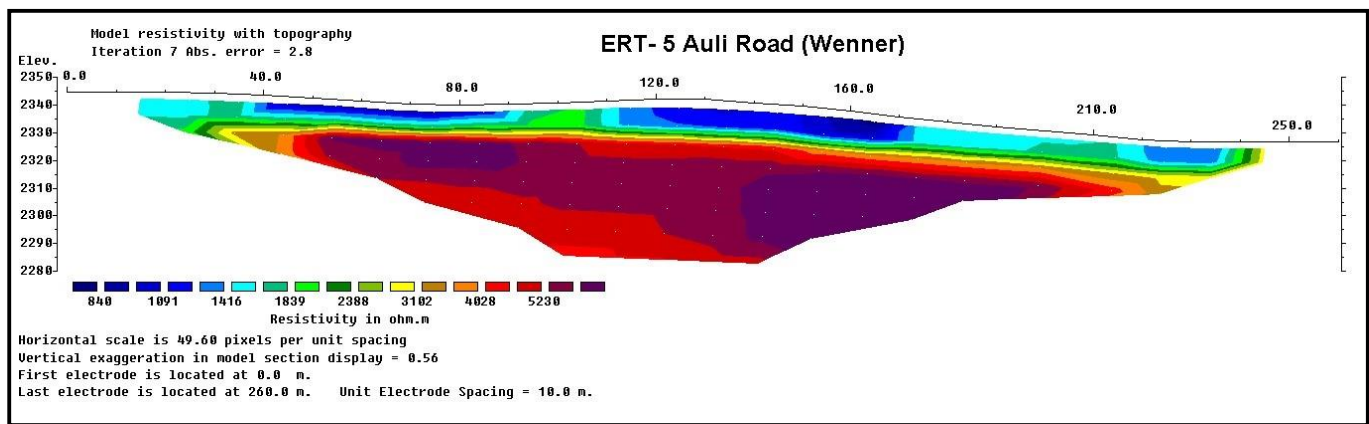
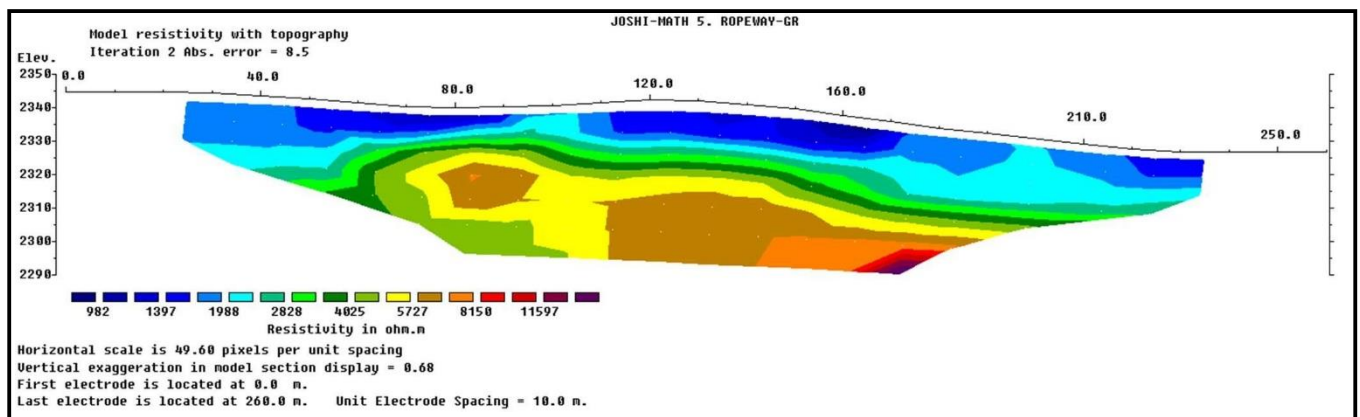
**Figure 11 A: 2-D Electrical Resistivity Tomography Section (Wenner) at Auli Road above the crown of subsidence, Joshimath (ERT-5), Chamoli District**

**Figure 11 B: 2-D Electrical Resistivity Tomography Section (Gradient) at Auli Road above the crown of subsidence, Joshimath (ERT-5), Chamoli District**

ERT-5 conducted as a roll along of ERT-4 towards east covering profile length of 250 m distance (Fig. 11A & 11 B). A patch of relatively low resistivity (800-900 ohm.m) was also observed compared to the surrounding resistivity values (more than 2000 ohm.m) on ERT-5 profile between 120 and 170 m distance on profile line. It may be indication of fracture in consolidated rock up to the depth of about 10 m bgl.

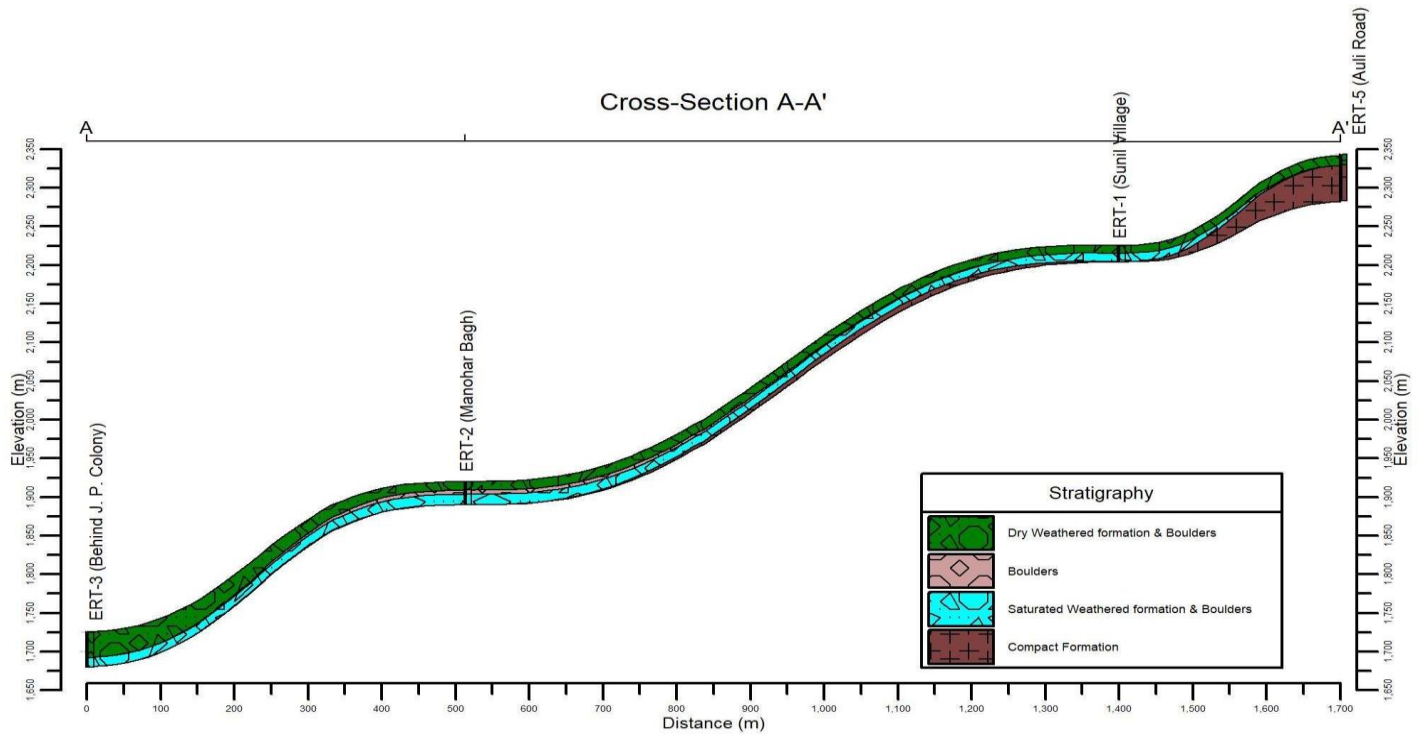
**Figure – 12 A - lithological section from J P colony in North to about 300 m away from Sunil Village, Joshimath, Chamoli District**

On perusal of the Figure 12 A, it is observed that thickness of the unconsolidated material increasing from Auli Road to J P Colony. Occurrence of water saturated formation becomes deeper from Auli Road to J P Colony. Ground water flows towards North direction (Fig 13). Large boulders are embedded in loose material especially in and around Manohar bagh. Findings of hydrogeological and geophysical studies conducted in the area reveals that the thickness of overburden (loose material) and saturated zone are comparatively more in Manohar Bagh-Singhdhar area, which may causes this area becomes susceptible to land subsidence. Further, the crack and subsidence in the area have relation with low resistivity shallow zones with groundwater flow occurring within 50 m depth.

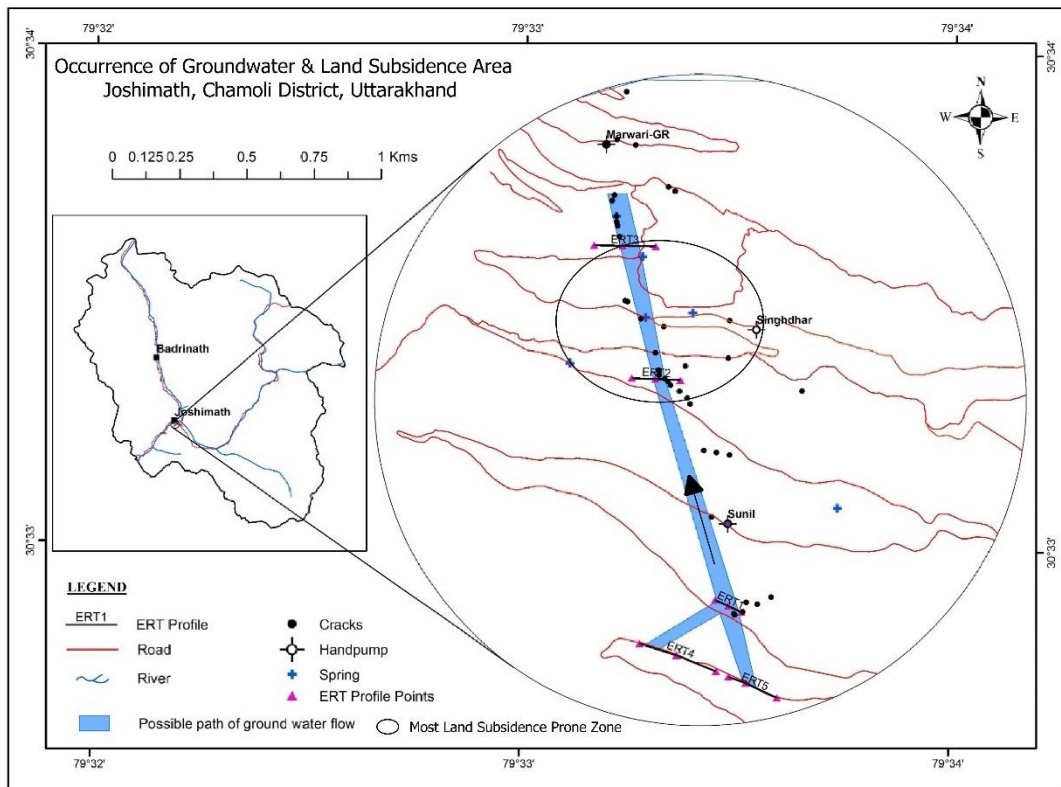
**Figure – 13- Occurrence of Groundwater and Land Subsidence Area, Joshimath, Chamoli District**

- The cracks, spring and handpumps present in the area are aligned in the same zone. Occurrence of all three in the same zone indicates that strata are saturated with the ground water. Ground water saturated zone may accelerate the land subsidence. The significance of geophysical survey is very important as it reveals the subsurface lithology. The ERT has been conducted at five places with different length of spreading (100- 240 M). The ERT data shows that loose sediment embedded with large boulder exists upto 35 -40 m bgl. In addition, the outcome of the geophysical study infers that low resistivity zone i.e., water saturation zone occurs all along the cracks zone. Ground water flows towards north with steep hydraulic gradient. At some places of ERT, low resistivity zone occurs below high resistivity zone which indicate that big boulders are embedded within unconsolidated water saturated sediment and due to sudden gush of water, balance of boulders are also disturbed. As these boulders supports many constructed structures, disbalance in the boulder causes the cracks in the structures.
