A Hydrogeological Investigation Report on Land Subsidence in Joshimath Town, Chamoli District, Uttarakhand

By
Central Ground Water Board,
Department of Water Resources, River Development and
Ganga Rejuvenation, Ministry of Jal Shakti
Govt of India, Dehradun

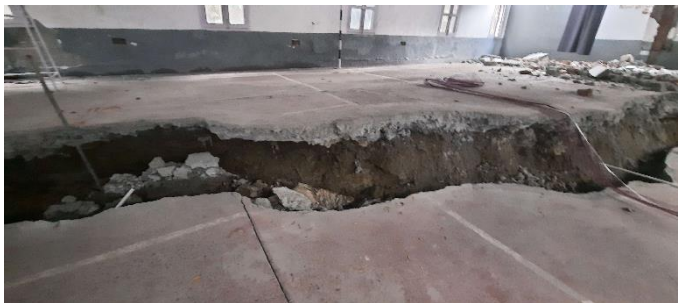
(A) Badminton Indoor Stadium, J P Colony

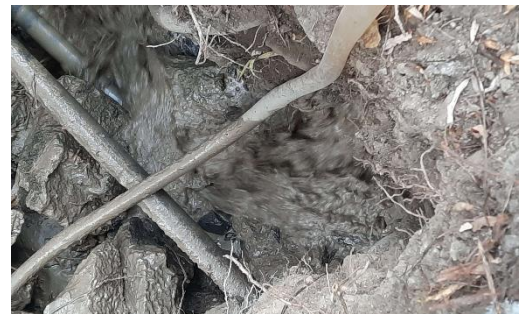
(B) Sudden Gush of Water near Badminton Indoor Stadium, J P Colony

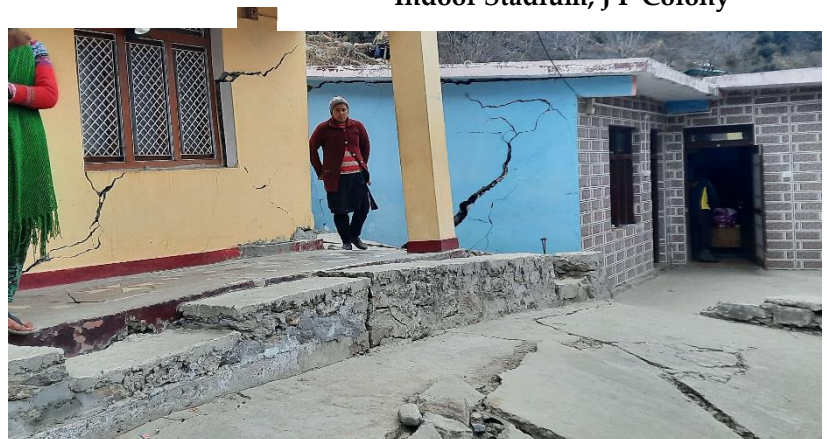
(D) Cracks Developed in House of Sh Vinod Saklani, Sunil Village

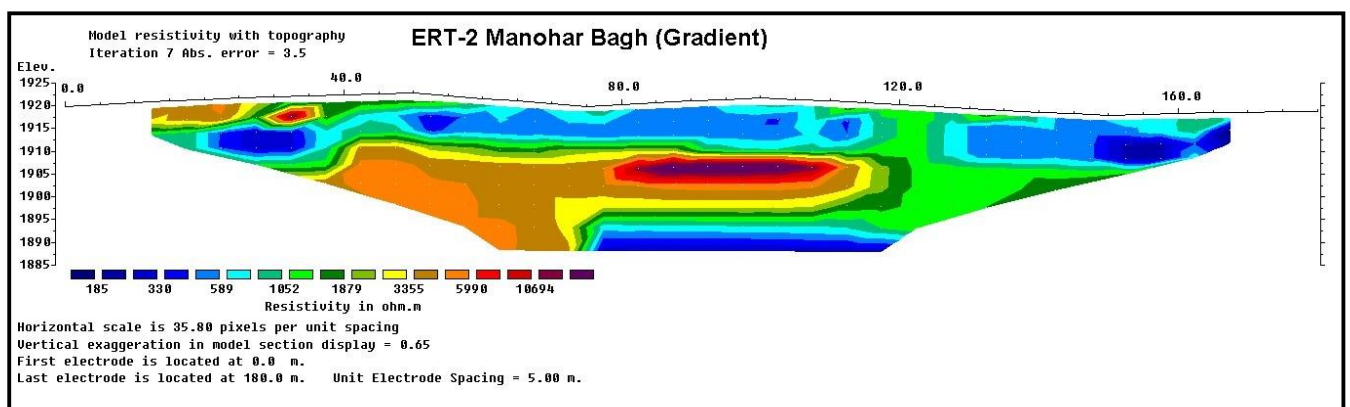
Figure 8A: 2-D Electrical Resistivity Tomography Section (Wenner) at Manohar Bagh, Joshimath (ERT-2), Chamoli District

Second ERT has been conducted at Manohar Bagh area of Joshimath town where intensity of cracks is maximum. Length of ERT profile was 180 m and maximum depth of investigation is about 35 m bgl. Altitude of the ERT point is 1920 m amsl and it is about 500 m distance towards north from ERT-1. The ERT results shows that the loose formation and boulders are present under saturation with water below the depth of 30 m bgl (Figure 8A & 8 B).

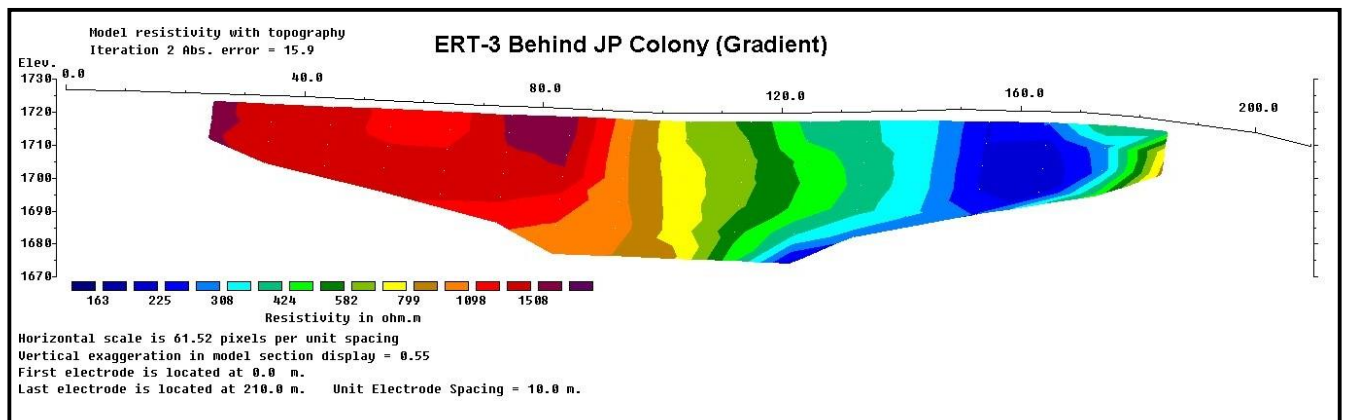
Figure 9 A : 2-D Electrical Resistivity Tomography Section (Wenner) between Singhdhar and JP Premise, Joshimath (ERT-3), Chamoli District

Third ERT was conducted 200 m south of the spot where sudden gush of water occurred on 2 / 3rd of January 2023. Here, the spread of ERT profile was 230 m and maximum depth of investigation was about 50 m (Fig.9A & 9B). ERT-3 results shows that area lying west of the cracks zone is consolidated in nature. East of the cracks zone have resistivity values in range of 200 – 300 ohm.m at a depth of 10 m to 50 m bgl which indicates the formation encounter in this depth range is saturated with water on the ERT profile between distance 100 and 170 m. It has the 70 m in horizontal extends which may act as path of the subsurface water flow.

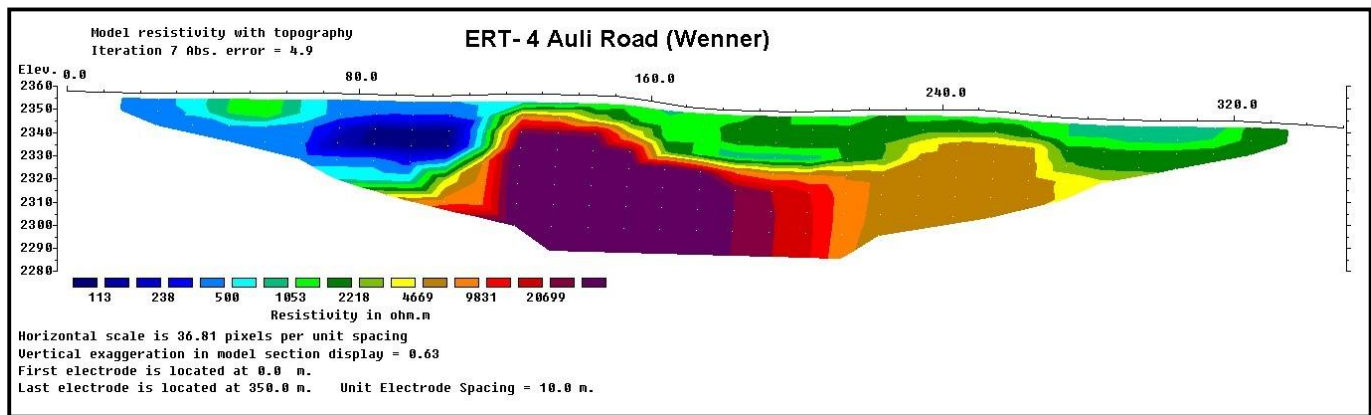
Figure 10 A: 2-D Electrical Resistivity Tomography Section (Wenner) at Auli Road above the crown of subsidence, Joshimath (ERT-4)

ERT-4 carried out along the Auli road in NW-SE direction about 200 m towards SW of the Sunil Village (Fig. 10 A & 10 B). A patch of low resistivity (100-300 ohm.m) was observed on the ERT-4 profile line between the distance of 50 and 100 m indicates the presence of saturated loose formation with boulders up to depth of about 25 m bgl.

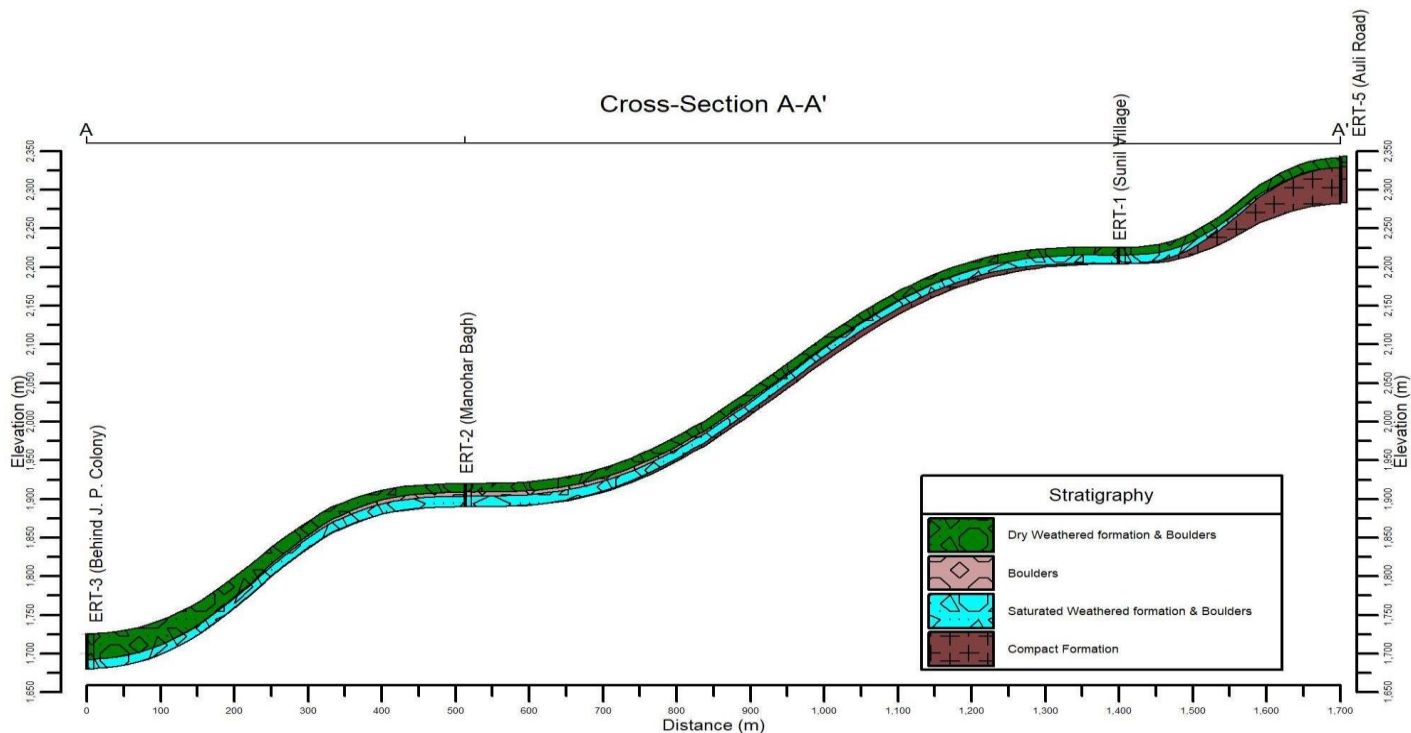
Figure – 12 A - lithological section from J P colony in North to about 300 m away from Sunil Village, Joshimath, Chamoli District

On perusal of the Figure 12 A, it is observed that thickness of the unconsolidated material increasing from Auli Road to J P Colony. Occurrence of water saturated formation becomes deeper from Auli Road to J P Colony. Ground water flows towards North direction (Fig 13). Large boulders are embedded in loose material especially in and around Manohar bagh. Findings of hydrogeological and geophysical studies conducted in the area reveals that the thickness of overburden (loose material) and saturated zone are comparatively more in Manohar Bagh-Singhdhar area, which may causes this area becomes susceptible to land subsidence. Further, the crack and subsidence in the area have relation with low resistivity shallow zones with groundwater flow occurring within 50 m depth.
