GOVERNMENT OF INDIA
MINISTRY OF JAL SHAKTI
Department of WR, RD and GR
CENTRAL GROUND WATER BOARD

**SPRING STUDIES AND ITS MANAGEMENT IN JAMPUI HILLS, NORTH
TRIPURA DISTRICT
(AAP 2021-22)**

**NORTH EASTERN REGION
GUWAHATI
January, 2023**

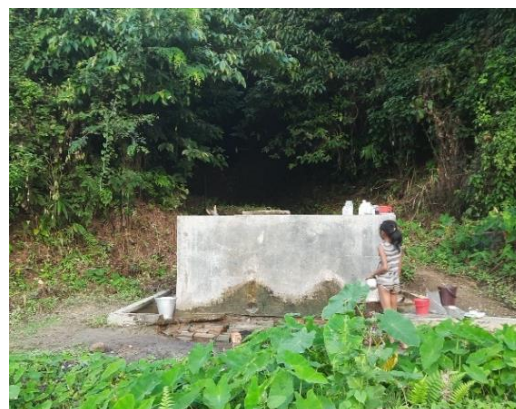
Figure 13: Shantipur-2 Spring

The spring is located on the Right Hand Side while coming from Ananda bazar at an elevation of 121.3m amsl. The slope of hill is 60 to 70° and aspect is towards northeast. Laminated layered weathered shale formation with thick vegetation cover the area and water from the spring is stored in the storage tanks. The water is being used for drinking and domestic purpose.

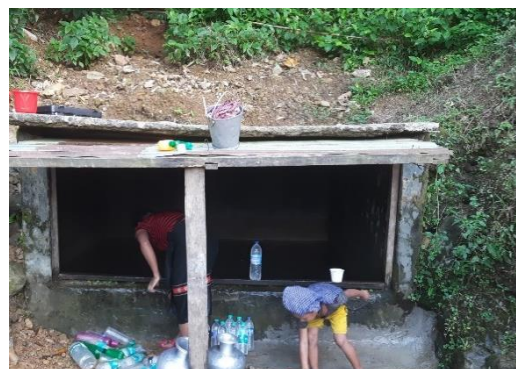
Figure 14: Khantlang-1 spring

The spring is located on the RHS of the road towards Paschim Bandarima approximately 150 m downslope. The spring is located at an elevation of 650.9 m amsl. The slope is 60 to 70° and aspect is towards west. The rock type consisting of consolidated fractured sandstone formation. The spring is used for drinking & domestic purpose. Beetle nut plantation observed at the top of spring.

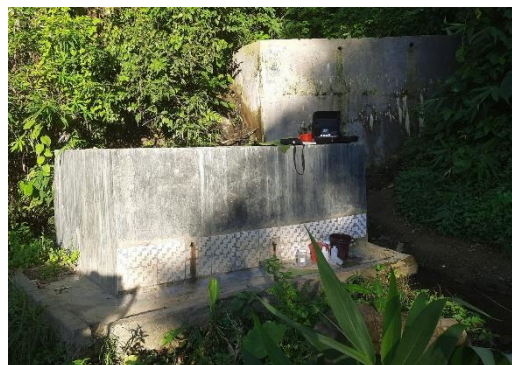
Figure 15: Khantlang 3 spring

The spring is located on the Left hand side while coming from Vangmun at an elevation of 380.2m amsl. Slope is 60 to 70° and aspect is towards southwest. Consolidated sandstone of fractured nature present at the area with forested thick vegetation. The spring is used for drinking & domestic purpose.

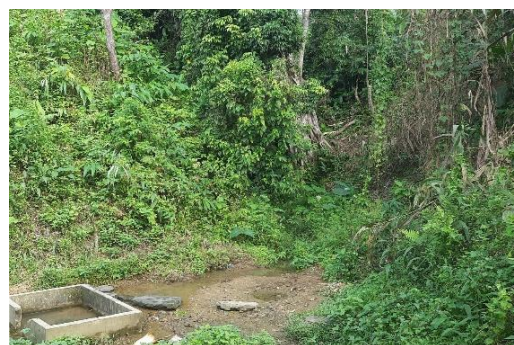
Figure 17: Zomuantlang 2 spring

The spring is located on the RHS of the road towards Vahnmun approximately 300 m downslope. The spring is located at an elevation of 680 m amsl. The slope is 40 to 50° and aspect is towards northeast. The rock type consisting of weathered sandstone and soil. The spring is primarily used for domestic purpose.

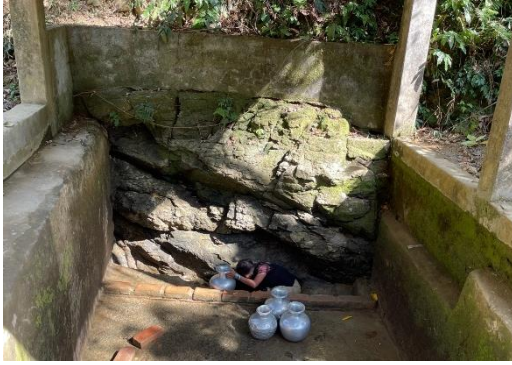
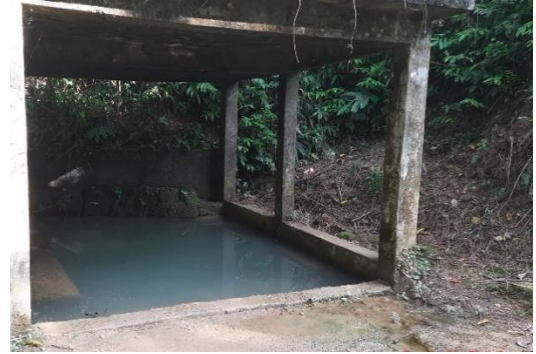
Figure 18: Phuldungsei 1 spring (pre-monsoon)

The spring is located on the RHS of the road towards Vahnmun approximately 300 m downslope at an elevation of 835 m amsl. The slope is 50 to 60° and aspect is towards west. The area consisting of consolidated sandstone formation fractured in nature. The spring is used for drinking and domestic purpose.

Figure 19: Phuldungsei 1 spring (post-monsoon)

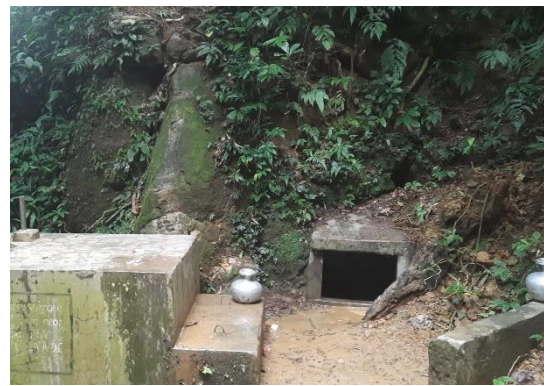
Figure 20: Phuldungsei 2 spring

The spring is located on the RHS of the road towards Vahnmun approximately 200 m downslope. The spring is located at an elevation of 835 m amsl. The slope is 40 to 50° and aspect is towards northeast. The rock type consisting of consolidated sandstone formation fractured in nature. The spring is being used for drinking and domestic purpose.

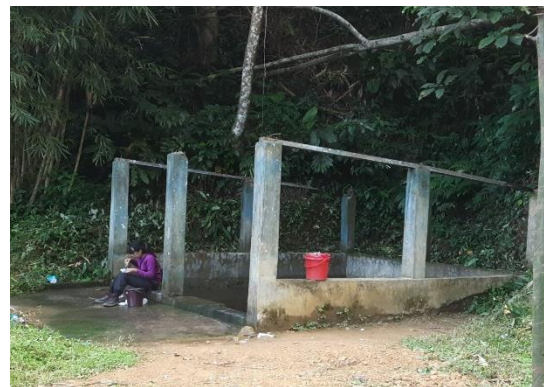
Figure 21: Phuldungsei 3 spring

The spring is located LHS of the road on the way to Betliansib (the highest peak of Jampui hills range.) below the TSR camp approximately 100 m downslope, at an elevation of 867.8 m amsl. The slope is 60 to 70° and aspect is towards northeast. The area consisting of weathered sandstone with soil Unit. The spring is used for domestic purpose.

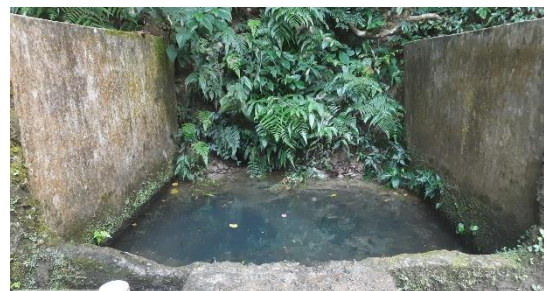
Figure 22: Phuldungsei 4 spring

The spring is located on the LHS of the road next to church while coming from vanghmun, located at an elevation of 828 m amsl. The slope is 50 to 60° and aspect is towards east. The area consisting of consolidated sandstone covered with surface soil. The spring is used for domestic purpose.

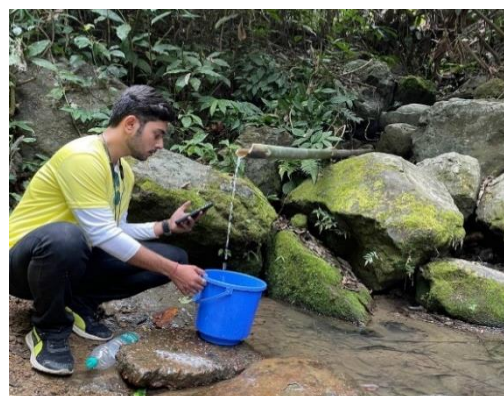
Figure 23: Sabual spring

The spring is located on the RHS of road towards Vanghmun approximately 1 km downslope from the road located at an elevation of 724.6 m amsl. The slope is 50 to 60° and aspect is towards southeast. The area consisting of consolidated fractured sandstone formation. The spring is primarily used for drinking and domestic purpose.

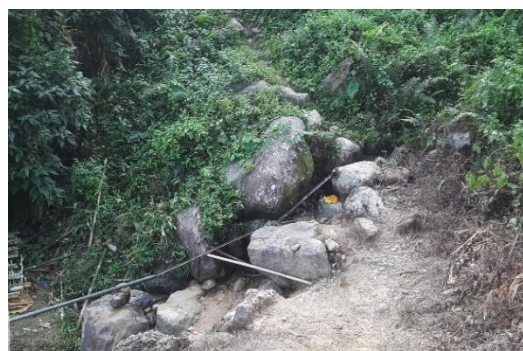
Figure 24: Tenkypara 1 spring

The spring is located on the RHS of road while towards vanghmun approximately 300 to 400 m downs from the road at an elevation of 700.2 m amsl. The slope is 50 to 60° and aspect is towards east. The area consisting of Consolidated sandstone covered with surface soil. The spring is primarily used for drinking and domestic purpose.

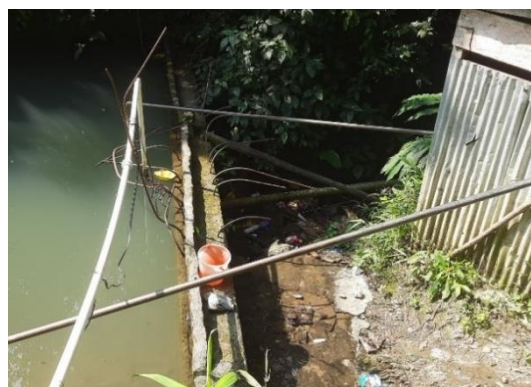
Figure 25: Tlangsang 1 spring

The spring located on the RHS of road towards vanghmun approximately 700 to 800 m downslope next to the Tlangsang Training Academy teachers residence at an elevation of 609.4 m amsl. The slope is 50 to 60° and aspect is towards east. The area consisting of consolidated sandstone covered with surface soil. A check dam is constructed on downslope to collect spring water. This water is then supplied to the Tlangsang training academy and nearby habitation for drinking & domestic purpose.

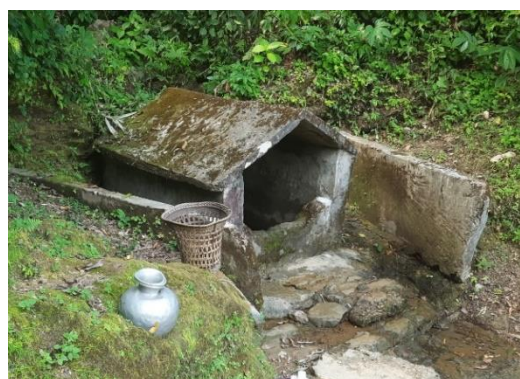
Figure 26: Tlangsang 2 Spring

The spring is located LHS of the road next to the shop with Tlangsang village entry point approximate 600 m away downslope from road, at an elevation of 746.8 m amsl. The slope is 50 to 70° and aspect is towards east. The area consisting of consolidated sandstone formation. The spring is used for drinking & domestic purpose.

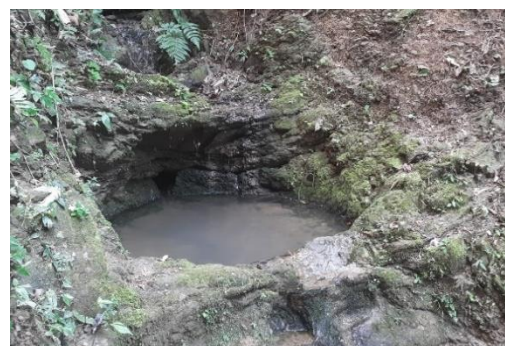
Figure 27: Tlangsang 3 spring

The spring is located on the RHS of the road next to the church approximately 200m downslope towards Vnghmun at an elevation of 740.8 m amsl. The slope is 50 to 60° and aspect is towards east. The area consisting of fractured consolidated sandstone beds. The spring is used for drinking & domestic purpose.

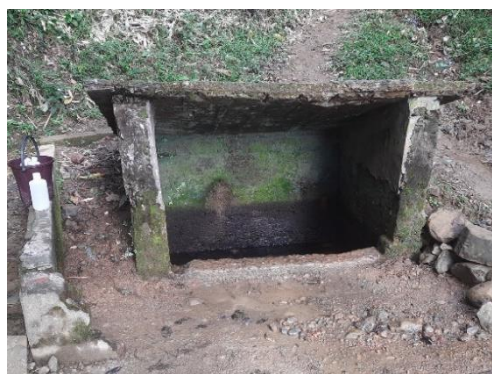
Figure 28: Tlangsang 4 spring

The spring is located RHS of the road next to the Tlangsang ICDS centre is approximate 200 m downslope from the road, at an elevation of 738 m amsl. The slope is 50 to 70° and aspect is towards east. The area consisting of consolidated sandstone formation. The spring is used for drinking & domestic purpose.

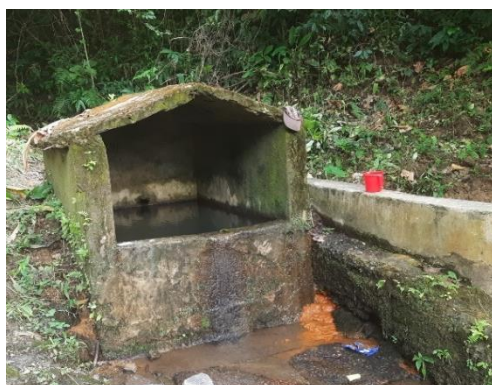
Figure 29: Tlangsang 5 spring

The spring is located on the RHS of road while coming from vanghmun below the bus stop approximately 350-400 m downslope at an elevation of 272 m amsl. The slope is 60 to 70° and aspect is towards east. The spring is used for drinking & domestic purpose.

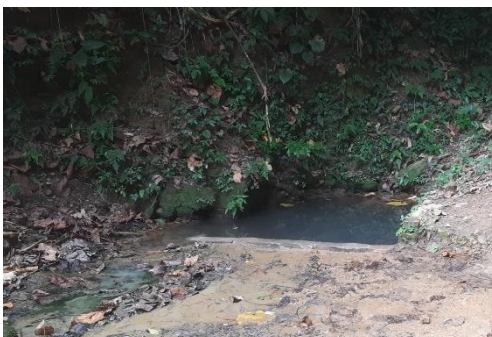
Figure 30: Belianchip spring

The spring is located on the RHS of road towards the Belianchip view point below vehicle repairing workshop approximately 200 m downslope at an elevation of 649.4 m amsl. The slope is 45 to 50° and aspect is towards east. The lithology consisting of consolidated Sandstone formation. The spring is used for domestic purpose.

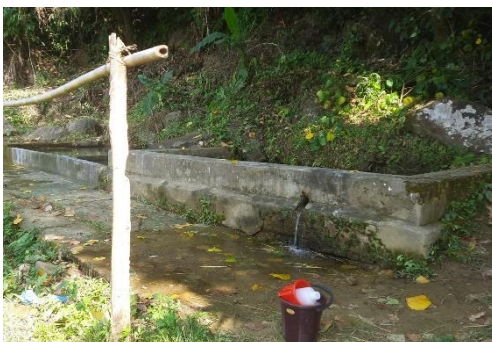
Figure 31: Hmunpui 1 spring

The spring is located on LHS of road towards Vanghmun just beside the main road approximately 100 m elevation at elevation of 491.2 m amsl. The slope is 50 to 60° and aspect is towards east. The area consist of consolidated Sandstone formation. The spring is used for domestic purpose.

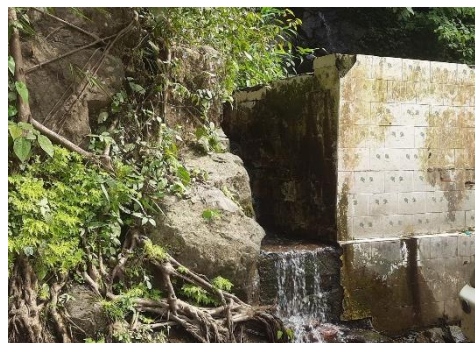
Figure 32: Hmunpui 2 spring

The spring is located on the LHS of road towards Vanghmun just adjacent to the main road at an elevation of 347.6 m amsl. The slope is 70 to 80° and aspect is towards east. Lithologically the area contains consolidated sandstone with surficial soil. The spring is used for drinking & domestic purpose.

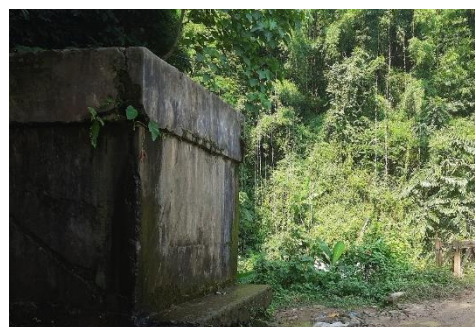
Figure 33: Along the Thumlai road water front

The spring is located on RHS of road while coming from Eden tourist lodge just adjacent to the main road at an elevation of 467.3 m amsl. The slope is 50 to 60° and aspect is towards east. The area consist of consolidated sandstone formation of fractured nature. The spring is primarily used for drinking and domestic purposes.

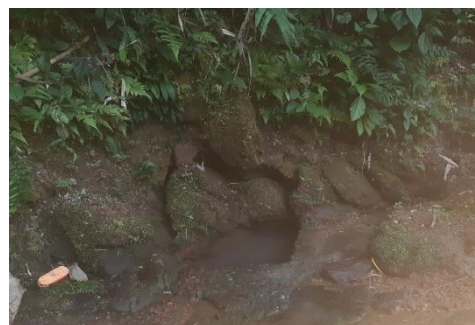
Figure 34: Ruchokon Spring

The spring is located on RHS of the road towards Vanghmun approximately 250 m downslope at an elevation of 546 m amsl. The slope is 50 to 60° and aspect is towards east. The area consists of consolidated sandstone of fractured nature. The spring is used for domestic purpose only.

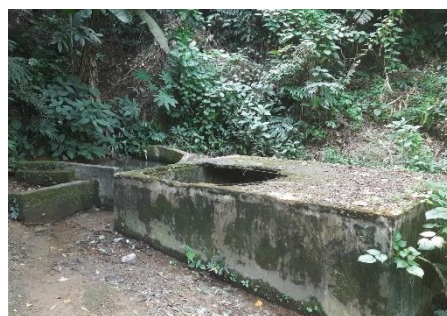
Figure 35: Tlakshi 1 spring

The spring is located below the Tlakshi church on the RHS of the motorable road approximately 250 m downslope, at an elevation of 574 m amsl. The slope is 60 to 70° and aspect is towards east. The rock type of the area is unconsolidated sandstone. Used for drinking & domestic purpose.

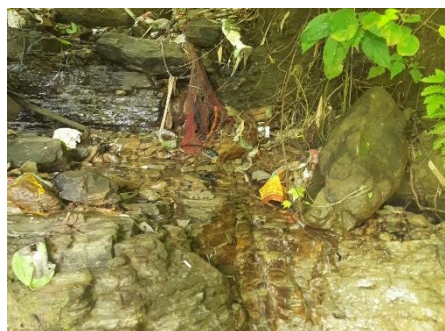
Figure 36: Hmuanchang 1 spring

The spring is located beside the road approximately 300 m downslope at an elevation 537.3 m. The rock type of the area is fine grained sandstone, grey in colour and fractured nature. The spring is being used for drinking and other domestic purposes.

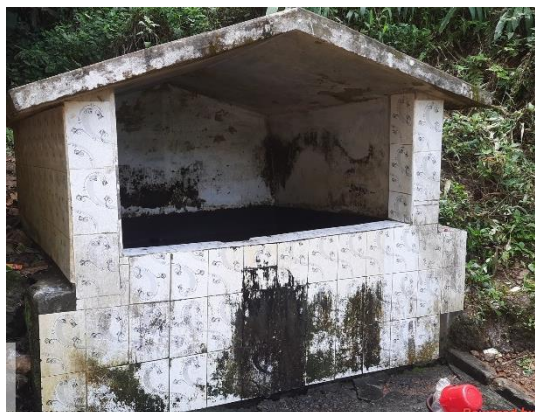
Figure 37: Hmuanchang 2 spring chamber

The spring is located beside the road approximately 200 m downslope from the water storage pumping unit at an elevation of 529.7 m amsl. The slope is 60 to 70° and aspect is towards east. The rock type of the area is unconsolidated sandstone. The spring is primarily used for drinking and domestic purposes.

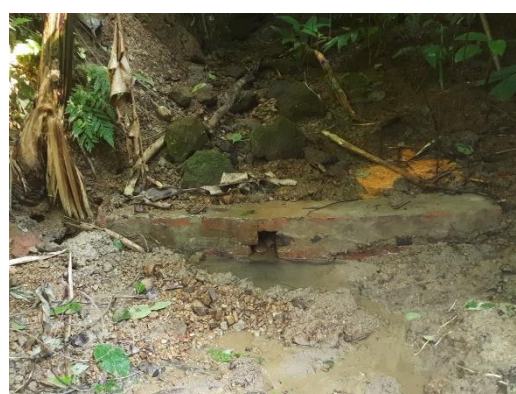
Figure 39: Vaisum 1 spring

The spring is located beside the road RHS on the way to Vaisum village approximately 250 m downslope inside the premise of water storage pumping unit at an elevation of 435.7 m amsl. The slope is 60 to 70° and aspect is towards east. The rock type of the area is consolidated sandstone covered with unconsolidated soil. The spring is primarily used for drinking and domestic purposes only.

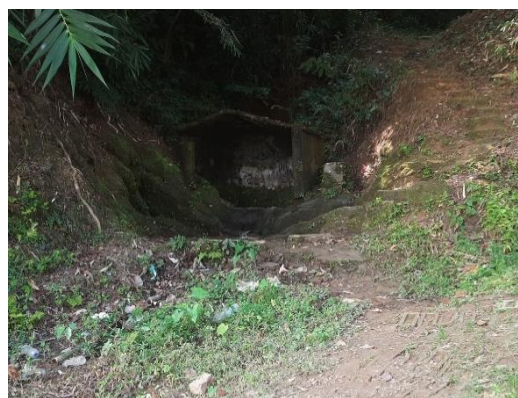
Figure 40: Vaisum 2 spring

The spring is located just adjacent to the main road on the LHS on the way to Damcherra at an elevation of 431.5 m amsl. The slope is 60 to 70° and aspect is towards east. The rock type of the area is unconsolidated sediments covering consolidated. The spring is being used by locals for drinking and other domestic purposes.

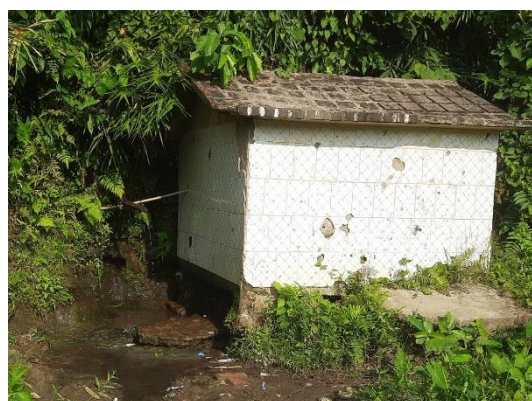
Figure 42: Khakchang Para spring

The spring is located just beside the main road on the RHS towards Damcherra an elevation of 77.7 m amsl. The slope is 60 to 70° and aspect is towards east. The rock type of the area is Consolidated sandstone covered with thin layer of unconsolidated soil. The spring is being used by locals for drinking & domestic purposes.

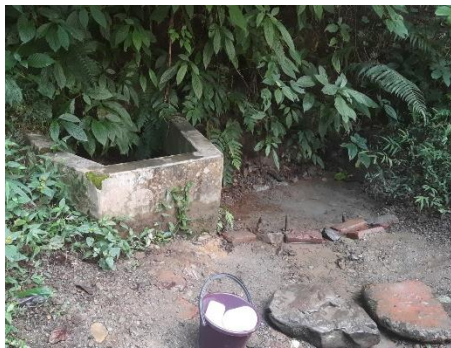
Figure 43: Vahnmun 2 spring

The spring is located just beside the main road on the RHS opposite of PNB bank of Vahnmun village approximately 300 m downslope at an elevation of 644.5 m amsl. The slope is 60 to 70° and aspect is towards east. The rock type of the area is unconsolidated sediments. The spring is primarily used for drinking and domestic purposes only.

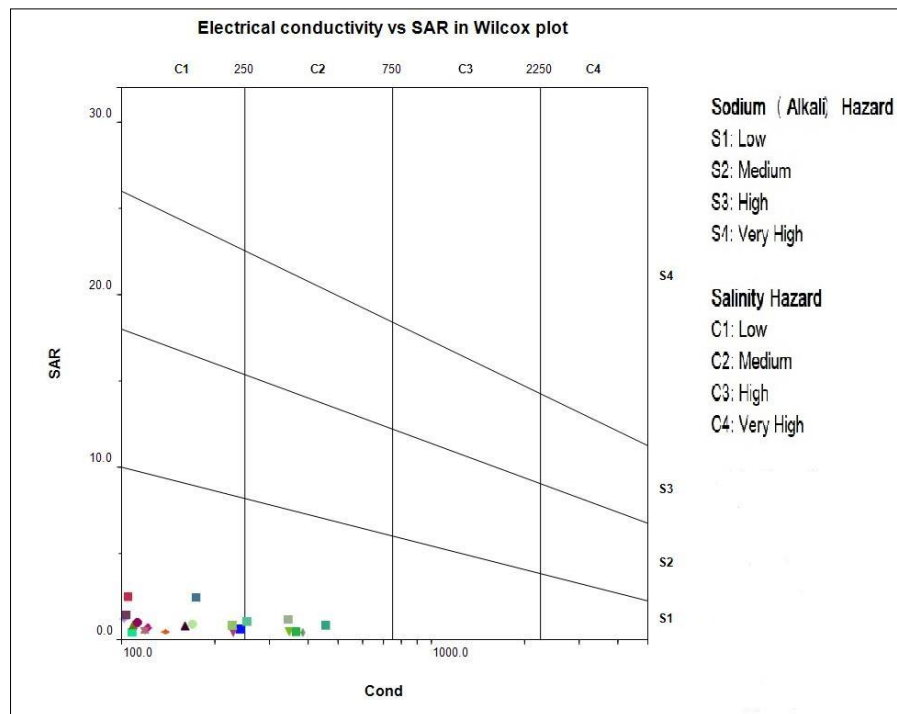
Figure 56: US salinity diagram showing the viability of water for irrigation purposes (Pre Monsoon spring samples)

The irrigation classification diagram developed by the US Salinity Laboratory Staff (1954) is a valuable tool that relates specific conductance (a measure of electrical conductivity) and sodium adsorption ratio (SAR) to assess the suitability of water for irrigation purposes. This diagram, commonly referred to as Figure 35, provides insights into the potential hazards associated with sodium and salinity levels in water used for irrigation.

Furthermore, during the pre-monsoon period, approximately 20% of the samples are classified as falling under the "low sodium and medium salinity hazard" category. This suggests that these samples exhibit low levels of sodium, mitigating the risk of soil

In general, spring water in the area is suitable for irrigation and industrial purposes. Wilcox diagram shows that 100% of samples during post monsoon fall under low sodium and low salinity hazard. The spring water can be used for irrigation with most crops on most soils with little likelihood that soil salinity will develop. Low sodium water can be used for irrigation on almost all soils with little danger of the development of harmful levels of exchangeable sodium.

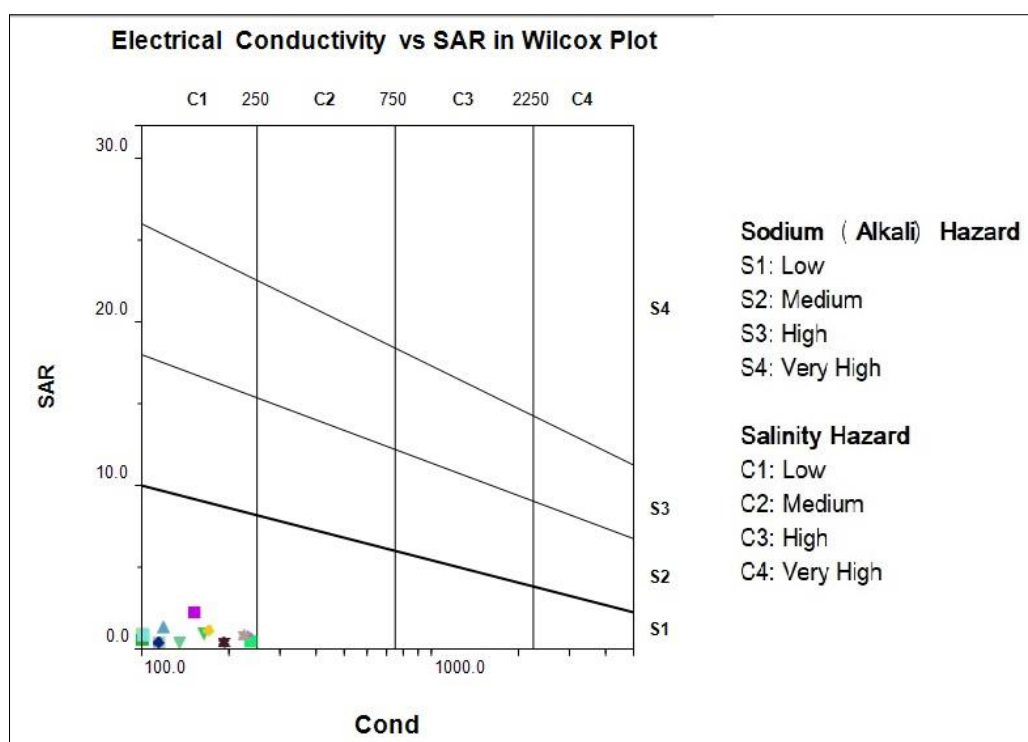
Figure 57: US salinity diagram showing the viability of water for irrigation purposes (Post Monsoon springs samples)

Analyzing the results within the framework of the irrigation classification diagram, it becomes apparent that during the post-monsoon period, all the collected samples fall within the "low sodium (alkali) hazard" category (C1) and the "low salinity hazard" category (S1). This indicates that the sodium concentration and overall salinity of the water samples are relatively low, posing minimal risks to soil quality and crop growth when used for irrigation purposes.

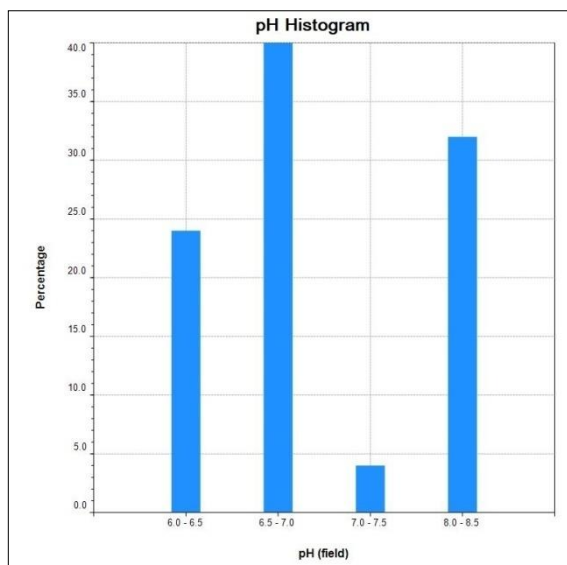
Figure 58: pH Histogram, Spring Samples (Pre Monsoon)

Very low or very high pH is not favorable for the growth of organisms and is not fit for animal and human consumption. The pH values of the spring water ranges from 7.47 to 8.64 during post monsoon and 6 to 8.4 during pre monsoon. The BIS (2012) has recommended acceptable range of pH from 6.5 to 8.5 for domestic use. Soda ash (sodium carbonate) and sodium hydroxide may be injected into a water system to raise the pH of water to near neutral.
