## **A Hydrogeological Investigation Report on Land Subsidence in Joshimath Town, Chamoli District, Uttarakhand**

**By**  
**Central Ground Water Board,**  
**Department of Water Resources, River Development and**  
**Ganga Rejuvenation, Ministry of Jal Shakti**  
**Govt of India, Dehradun**

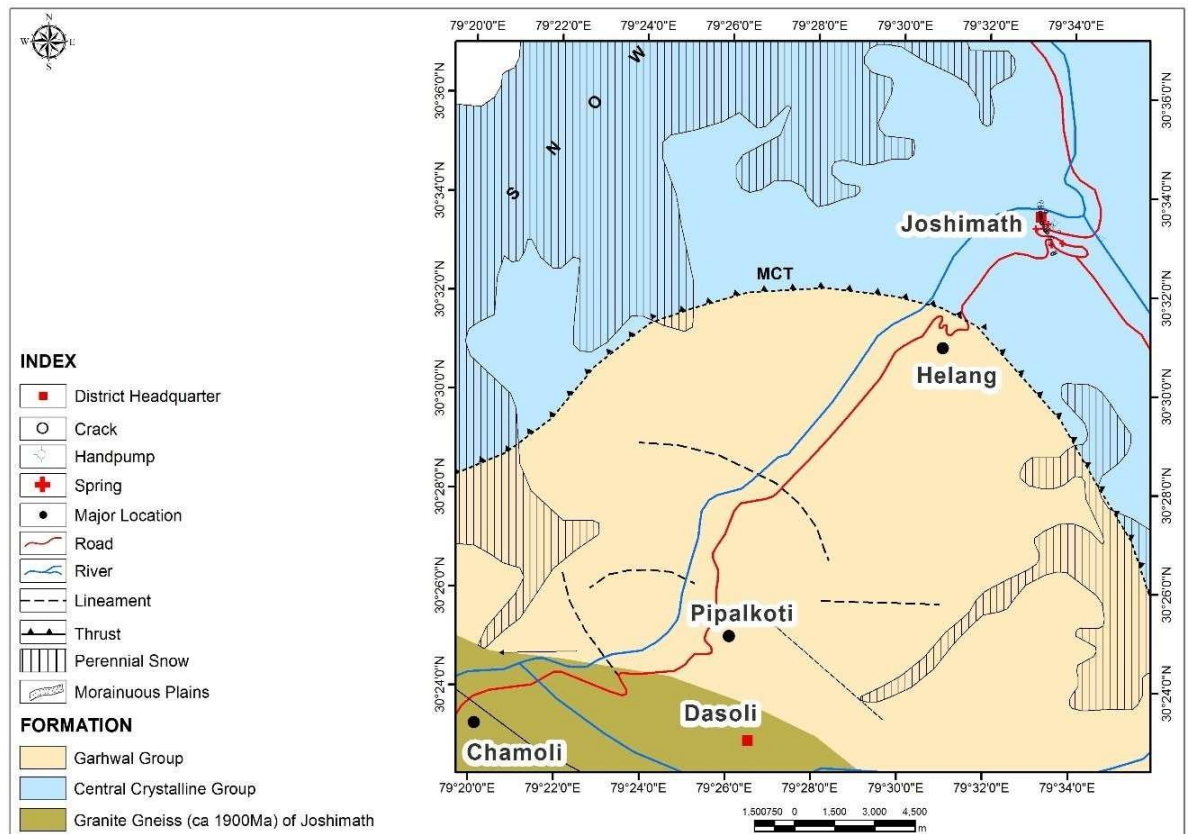
Figure- 2 Geology of Joshimath Area, Chamoli District

The Main Central thrust (MCT) traverse in southern part of the study area. Beside this there are number of weaker plains present in the area. The area along these weaker plains is highly vulnerable for landslides/land subsidence. (Figure- 2). Geological succession is furnished in Table -1

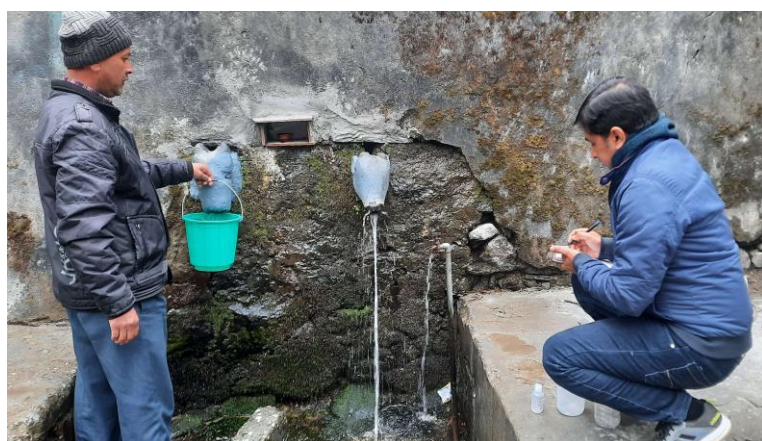
**Photo – 3 A Spring Monitoring at Singhdhar, Joshimath**

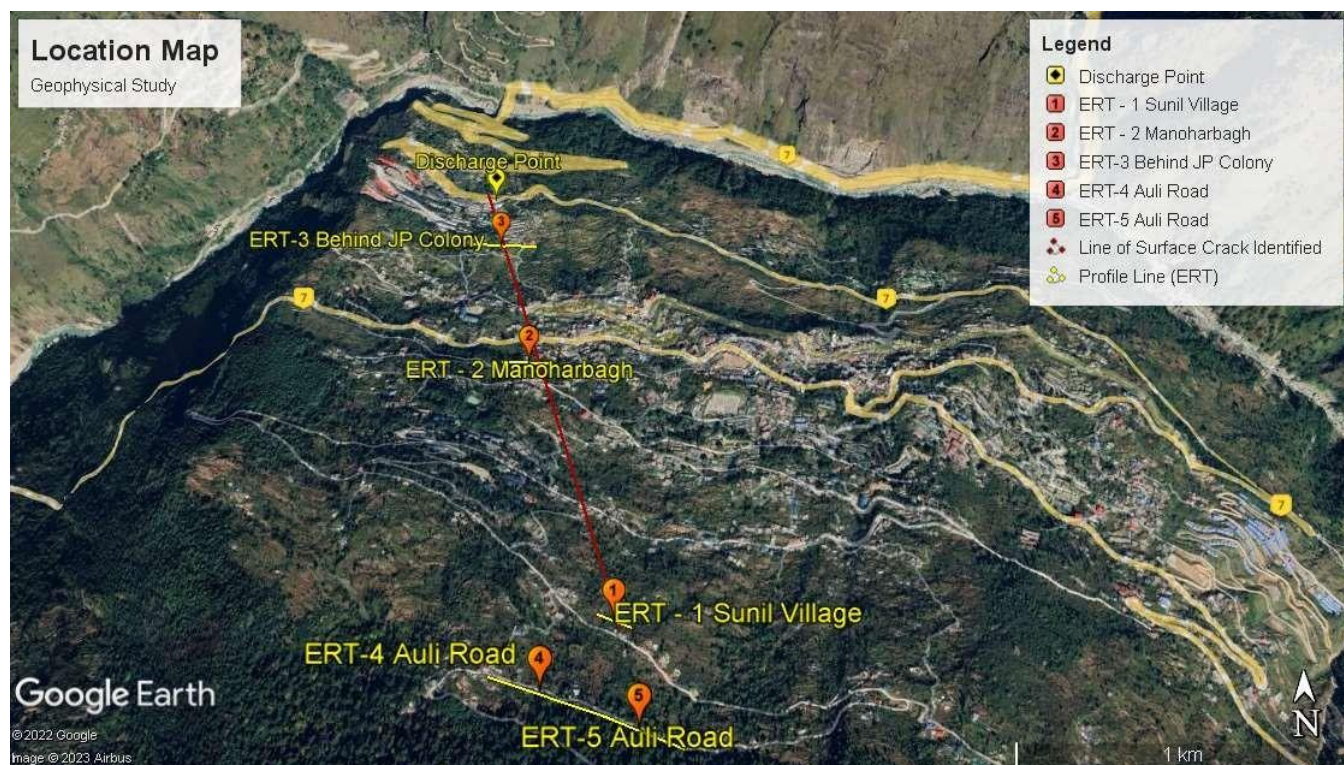
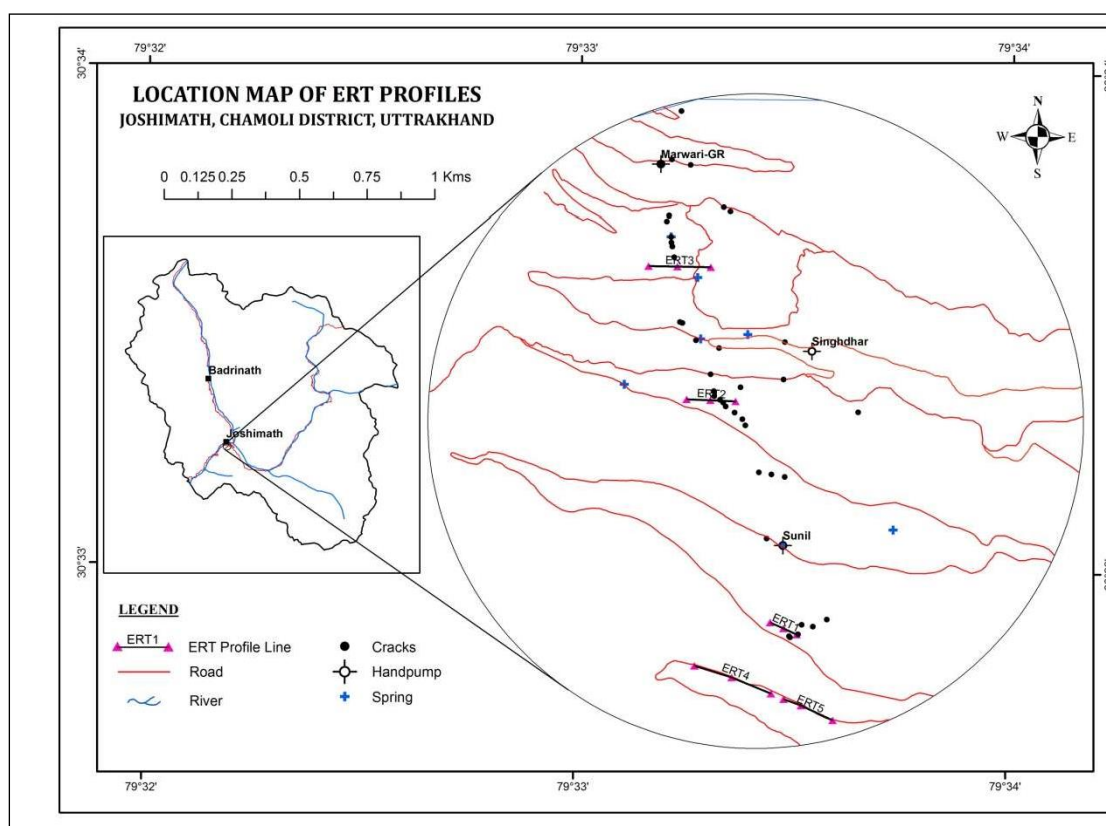
In the present study area, ERT profile lines are conducted at five locations across the cracks zone (Fig. 6 A & 6B). As the open land in Joshimath town is very limited, the spread for the ERT profiles varies from 105 m to 360 m. All efforts were done to locate the profile linear to cracked line/subsidence area and with a maximum space availability using two types of electrode configurations i.e., Gradient and Wenner configurations for maximum data and comparative study in NW-SE direction. The coordinates of profile line are given in Table 5. The data have been processed using RES2DINV software. On the basis of ERT results, low resistivity zones were identified i.e. weak zones which may be the cause of cracks/subsidence due to steep gradient of groundwater flow towards north. Overall, the two electrode configurations have yielded almost same the results. Topographically corrected model resistivity sections using Wenner and Gradient are shown Fig. 7 ( A & B), 8 ( A & B), 9 ( A & B), 10 ( A & B), 11 ( A & B) respectively.

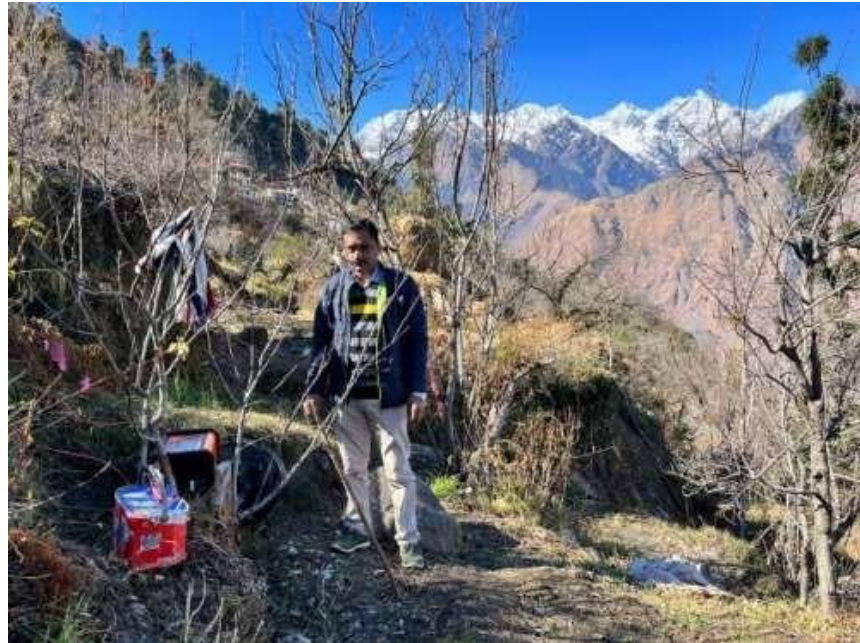
**Site-1 (ERT-1): In agricultural land of Sh Vinod Saklani, Upper Sunil, Joshimath, Chamoli District**

First 2D electrical resistivity tomography (ERT-1) has been carried out across the cracks developed in agricultural land of Sh Vinod Saklani Joshimath area, District Chamoli, Uttarakhand. Length of ERT profile was 105 m. Resistivity value received during ERT indicates that boulders are embedded into loose sediments. Saturated formation occurs at a depth of 15 m below ground level (Figure 7A & 7 B).

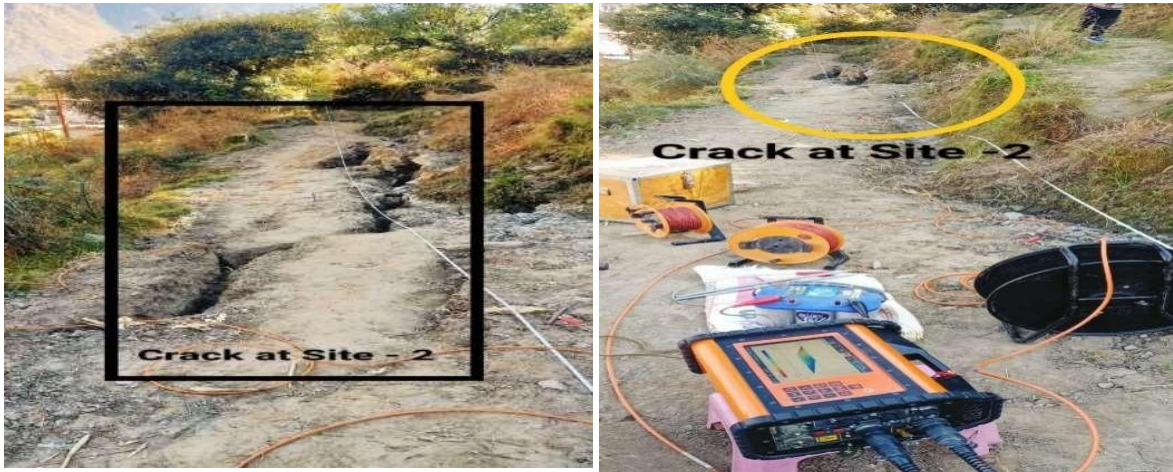
Site-2 (ERT-2): In agricultural land of Village Manoharbagh, Joshimath, Chamoli District

Second ERT has been conducted at Manohar Bagh area of Joshimath town where intensity of cracks is maximum. Length of ERT profile was 180 m and maximum depth of investigation is about 35 m bgl. Altitude of the ERT point is 1920 m amsl and it is about 500 m distance towards north from ERT-1. The ERT results shows that the loose formation and boulders are present under saturation with water below the depth of 30 m bgl (Figure 8A & 8 B).

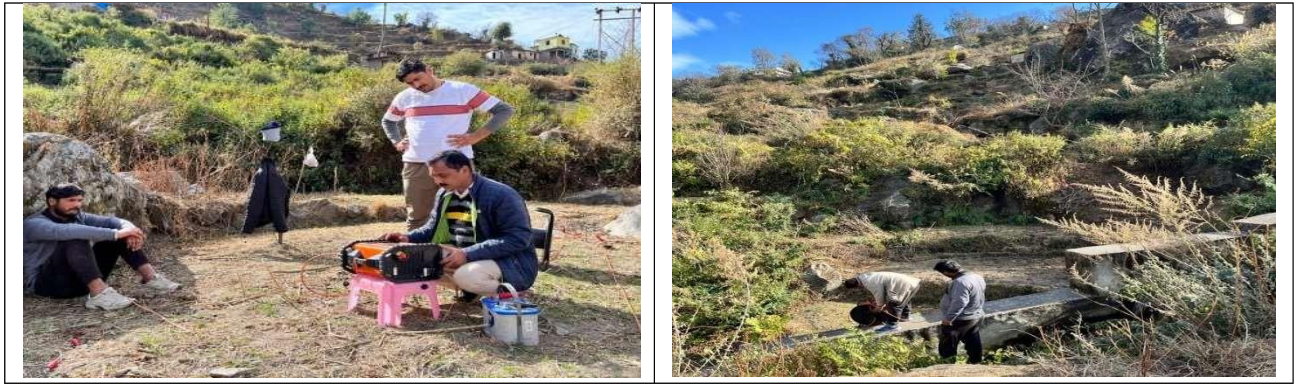
**Site-3 (ERT-3): In open land, between Singhdhar and JP Premise, Joshimath, Chamoli District**

Third ERT was conducted 200 m south of the spot where sudden gush of water occurred on 2 / 3<sup>rd</sup> of January 2023. Here, the spread of ERT profile was 230 m and maximum depth of investigation was about 50 m (Fig.9A & 9B). ERT-3 results shows that area lying west of the cracks zone is consolidated in nature. East of the cracks zone have resistivity values in range of 200 – 300 ohm.m at a depth of 10 m to 50 m bgl which indicates the formation encounter in this depth range is saturated with water on the ERT profile between distance 100 and 170 m. It has the 70 m in horizontal extends which may act as path of the subsurface water flow.

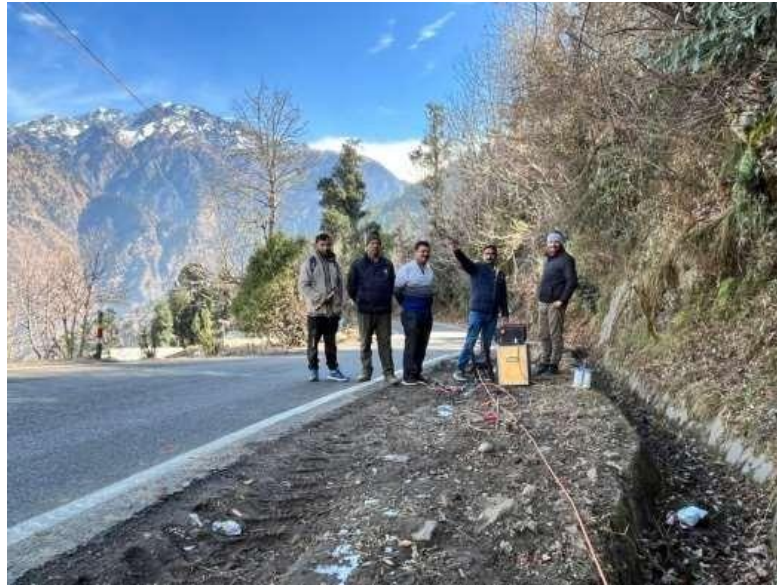
**Site-4(ERT-4): Just above the Upper Sunil Village towards Auli Joshimath, Chamoli District**

ERT-4 carried out along the Auli road in NW-SE direction about 200 m towards SW of the Sunil Village (Fig. 10 A & 10 B). A patch of low resistivity (100-300 ohm.m) was observed on the ERT-4 profile line between the distance of 50 and 100 m indicates the presence of saturated loose formation with boulders up to depth of about 25 m bgl.

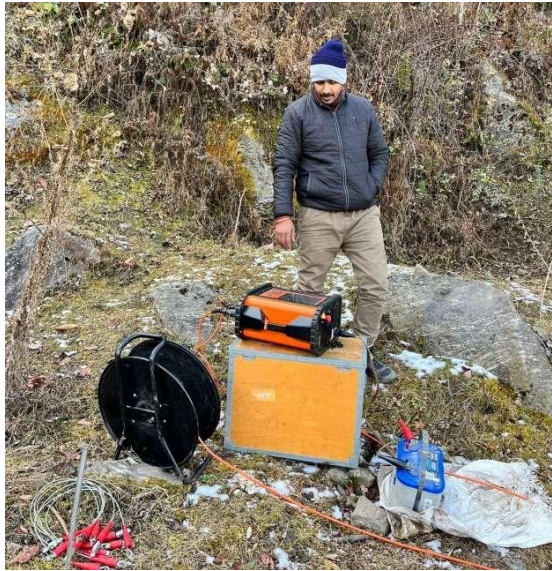
**Site-4(ERT-5): Just above the Upper Sunil Village towards Auli Joshimath, Chamoli District**

ERT-5 conducted as a roll along of ERT-4 towards east covering profile length of 250 m distance (Fig. 11A & 11 B). A patch of relatively low resistivity (800-900 ohm.m) was also observed compared to the surrounding resistivity values (more than 2000 ohm.m) on ERT-5 profile between 120 and 170 m distance on profile line. It may be indication of fracture in consolidated rock up to the depth of about 10 m bgl.
