A Hydrogeological Investigation Report on Land Subsidence in Joshimath Town, Chamoli District, Uttarakhand

By
Central Ground Water Board,
Department of Water Resources, River Development and
Ganga Rejuvenation, Ministry of Jal Shakti
Govt of India, Dehradun

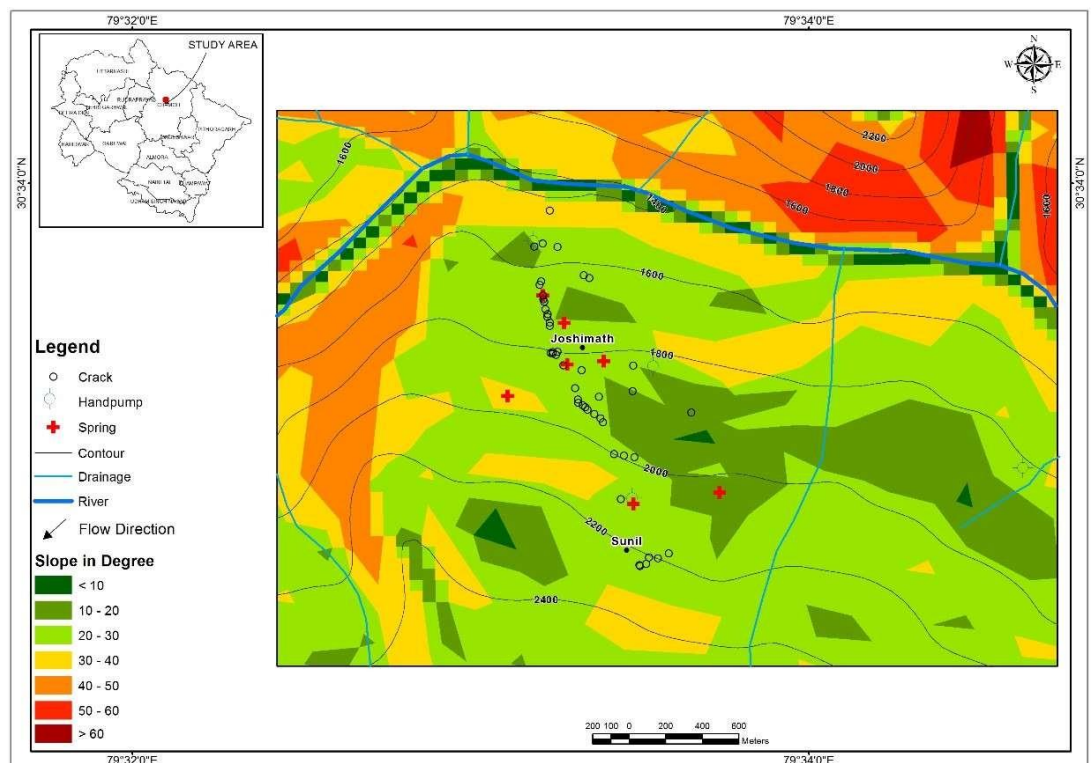
Figure- 3 C Slope Configuration in the Joshimath Town, Chamoli District, Uttarakhand.

A total of 46 cracks/subsidence zones are observed which are oriented in North-West to South-East direction (Figure- 3 A) (Annexure- I). The slope direction of the study area is South to North. (Figure- 3 B) The crown of the subsidence marks at house of Sh Vinod Saklani, Village Upper Sunil and extend upto JP township at Marwari village. The intensity of the cracks is increasing from south to north and it maximum observed in Manohar Bagh area where one of the hotels building lean over adjoining hotel building. The depth of the cracks observed in the agriculture land is upto 03 ft deep and 1-2 ft wide.

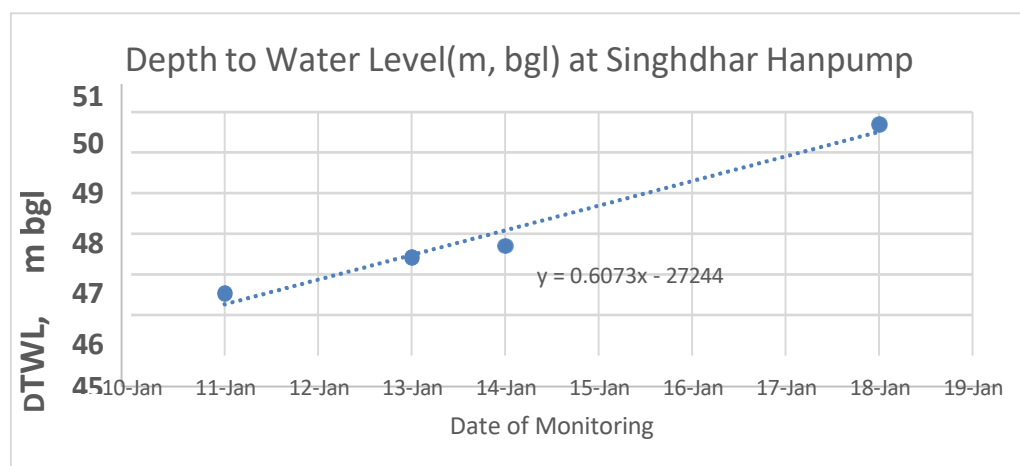
Figure 4 – Hydrograph of Singhdhar Handpump Joshimath Town, Chamoli District

Joshimath town is situated on morainic deposit, comprising thick Quaternary loose sediment. Big boulders are embedded in this deposit. The morainic deposit is both porous and permeable and hence suitable for groundwater development. The ground water is mainly developed through handpumps. The topography is highly undulating and geological formations are moderately to steeply dipping. Due to frequent undulations of high magnitude a continuous water table doesn't exist. However, permeable formation overlays an impermeable one, the water table exists, its extension depends upon the distribution of the aquifer forming rocks and topography. A total of 04 number of handpumps are present in the study area (Figure 3 A & 3 B) and as per the data available with Jal Sansthan, Joshimath, the handpump are drilled upto the depth of about 80 m and the zone tapped ranges from 65-80 m bgl. The depth of water level in these handpumps ranges between 18 to 48 m. Daily depth of water level has been monitored and it is observed that water level is declining in Singhdhar area, with various rate. 20- 60 cm per day, (Figure- 4) while in other handpumps the water level is almost content. (Table-2) The decline in Singhdhar handpump indicates that water bearing strata is linked with the land subsidence. Land subsidence may be extended in and around Singhdhar Handpump. The discharge of these handpumps was taken manually which is 17.65-20.27 lpm
